## FATIGUE, RESIDUAL STRENGTH AND NON-DESTRUCTIVE TESTS OF AN AGING AIRCRAFT'S WING DETAIL

**Abstract.** *This study concentrates on fatigue, residual strength and non-destructive tests of an aging aircraft's wing detail of the Finnish Air Force's Hawk Mk.51 jet trainer. The studied detail was the integral stiffener with a drain hole near the wing root. Fatigue tests were deemed necessary to verify experimentally the analytically observed short fatigue life, significant crack growth rates and eventually to re-assess the detail's inspection period for the fleet jets. The results of the study have been utilized e.g. at the complementary type approval accomplished for the Finnish Air Force's Hawk.*

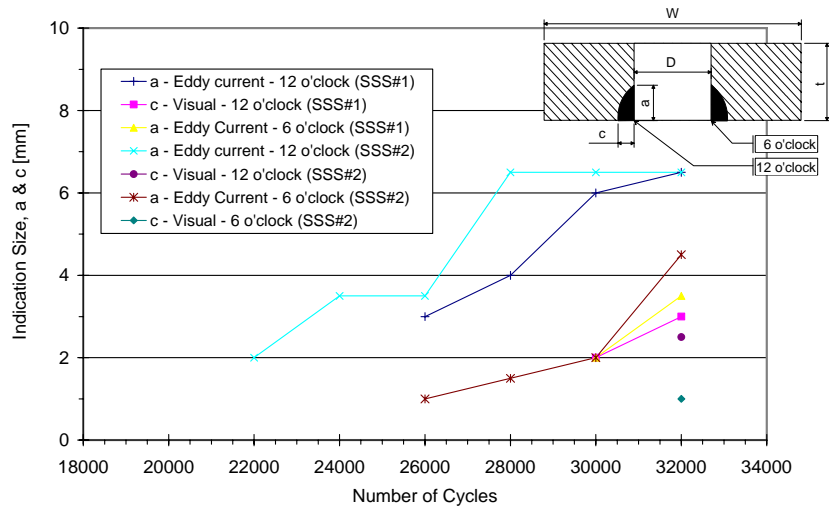
Figure 7: Indications of the Eddy Current and visual testing for two small scale-specimens<sup>3</sup>

In Figure 7 the results of the NDI testing are presented. According to the indications of Figure 7 the average crack growth takes approximately 6000-6500 cycles when the corner crack grows from the size of 1 mm (a) up to 6.5 mm through the thickness. The previously performed crack growth calculation<sup>1 6 9 10 11</sup> showed that the growth took about 5500 cycles which correspond to the indications quite good. The test results also indicated the fracture toughness of  $24.4 \text{ MPa}\sqrt{\text{m}}^{11}$  which is in line with the fracture toughness of  $29.7 \text{ MPa}\sqrt{\text{m}}^4$  (long-transverse) and  $19.8 \text{ MPa}\sqrt{\text{m}}^4$  (transverse-long) for aluminium 2014-T6.

The results of the NDI tests also indicated quite wide scatter in crack growth<sup>3 11</sup>. According to inspection tests the cracks tend to develop to the corners of the drain hole at 6 and 12 o'clock positions. Generally, a multiple crack pattern was observed. The NDI tests also showed that the appropriate initial crack size would be the corner crack of 2 mm x 1 mm (a x c, see Figure 7) which is caught with quite a high probability using the present NDI methods.

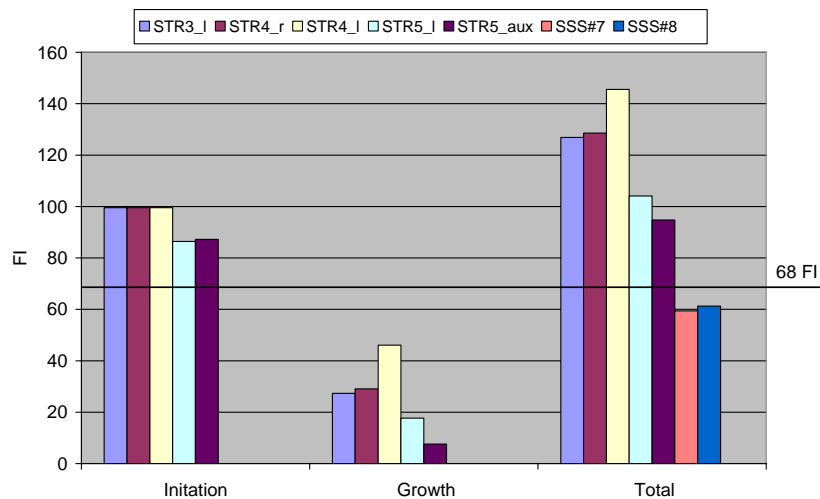
Figure 8: Results of the variable amplitude component specimen tests converted into FI<sup>3</sup>

In Figure 8 the fatigue test results of the variable amplitude tests are summarized. The data of Figure 8 include the life cycles prior to fatigue tests (i.e. the flight-induced FI consumption). The results of the small-scale specimens do not include the life cycle prior to

tests. The performed fatigue calculations showed that the stringer locations from which the small-scale specimens were cut of can stand exceedingly over 100 000 FI<sup>11</sup>. So the flight-induced FI consumption experienced prior to fatigue test cycling is negligible. In Figure 8 the initiation means life cycle consumption to the first flaw indication (ET) and the growth from that indication to failure. Now the margin against the crack initiation is about 1.4 and against the total life cycle is about 1.8. The crack growth takes on average 25.5 FI which means about 1900 FH based on the information of Table 3. On the other hand the crack growth scatter is significant from 7.6 FI to 46.1 FI. It is important to note that the test results are actual observations and they are not adjusted by any safety or scatter factors.

Based on the probability analysis crack initiation probability should be 6.6 %<sup>11</sup> at the point of 68 FI.
