# DETERMINATION OF THE FATIGUE CRACK-GROWTH RATES FROM FRACTOGRAPHIC ANALYSIS OF SPECIMENS REPRESENTING AIRCRAFT WING SKIN

**Marcin Ciesielski<sup>\*</sup>, Jerzy Kaniowski<sup>\*\*</sup>, Włodzimierz Karliński<sup>\*\*</sup>**

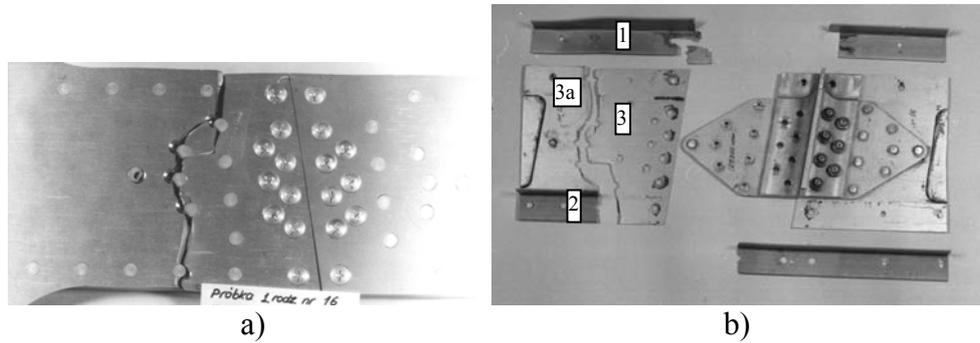
As the test log<sup>2</sup>, recorded during the specimen tests, stringer **1** was damaged the first (see fig. 3b), in the place of the M6 bolt hole. After 386 400 load cycles, the crack was detected during inspection preceding application of **7A** (ascending) loads step block (see load history in fig.

1), i.e. after 161 load blocks. Afterwards, skin cracks in the plane of four rivets, joining skin with doubler, were observed. Crack description in the report was as follows: crack running from the specimen edge with the stringer intact (stringer 2 in fig. 3b) to the distance 15 mm from the last rivet, then the crack runs through the row of three rivet holes (fig. 3a). This condition was observed during the next inspection, after 604 800 cycles (252 load blocks), during inspection preceding 7A step load series of the next loads block. Damage of the skin as a result of fatigue crack propagation took place after 608 397 cycles (253 load blocks) during loads in the second cycle of 1A step, in the 254<sup>th</sup> load block.

Fig. 3. The appearance of the specimen after the test (a) and its elements (b) after partial disassembly.  
Designations: **1** and **2** - stringers, **3** and **3a** - skin.

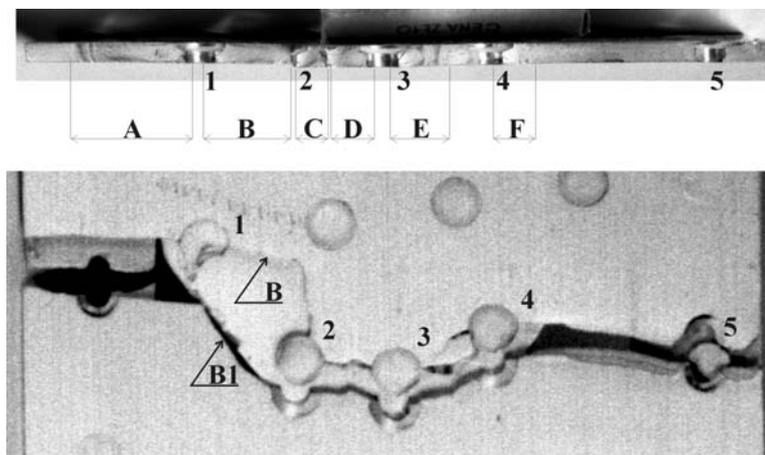
The analysis included fractures of the skin and both stringers. Distinct crack-growth bands were seen at the fatigue fracture of the skin. The fatigue fracture of the stringer **1** had no visible crack-growth bands, whereas fracture of the stringer **2** was of static type<sup>3</sup>. Skin crack goes along a broken line, crosswise through rivet holes. A fragment of the skin with a crack has been shown in fig. 4. Respective rivets were designated with numbers from **1** to **5**. Rivets **1** to **4** joins the skin with the doubler, rivet **5** joins the skin with the stringer. Respective fatigue sections of the fracture were designated with letters **A** to **F**. Length of the respective sections and the numbers of fatigue crack-growth bands are given in table 1. In some sections the fatigue fracture one cannot distinguish fatigue crack-growth bands. Their length has not been added to the length of the sections.

Fig. 4. Fracture and the position of skin crack. Numbers designate the rivet holes and letters refer to the fracture sections.

propagated to the rivet hole 2 in figure 4. The longest fatigue crack bands segment among all segments of the fracture confirmed that the cracking process started at hole 1 of the wing skin. The initiation of all the crack segments took place in the rivet holes. It was also observed that the cracks propagated from both sides of the holes and met between the holes as it is shown in figure 6 (segments C and D between holes 2 and 3) or passed by as it occurred e.g. between holes 1 and 2 or 3 and 4. Whereas, on the basis of the hitherto test one cannot determine in what order cracks were initiated from the successive holes.

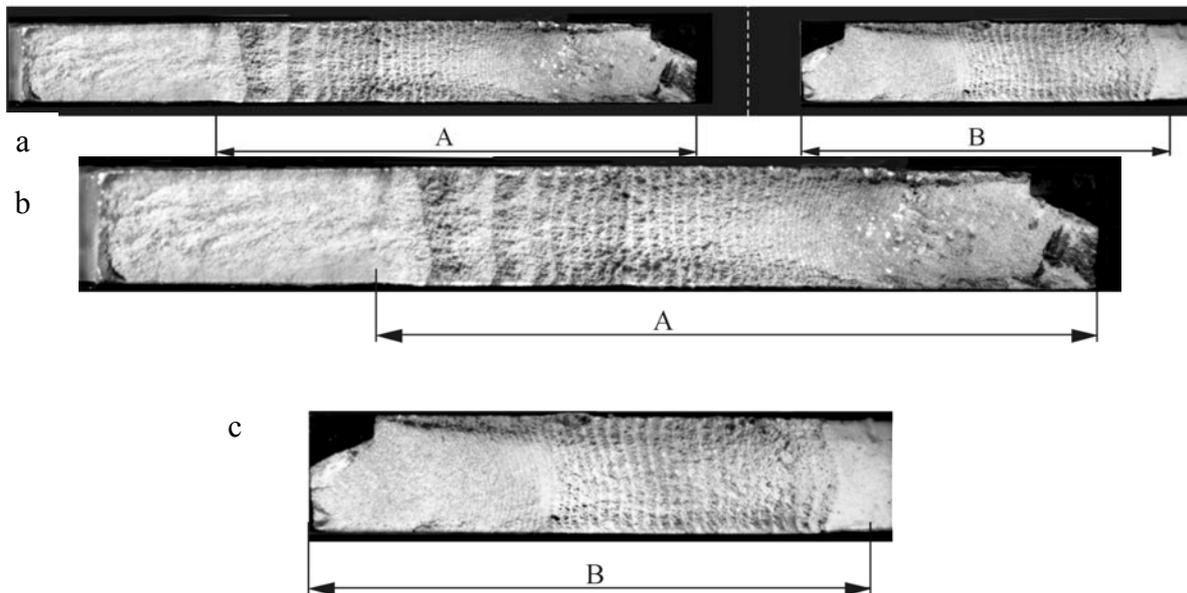
On the basis of macrofractographic analysis one can conclude that the initiation of the skin crack occurred in hole **1** on both of its sides (sections **A** and **B** in fig. 5). Fracture **A** propagated to the edge of the specimen, while fracture **B** from the other side of the hole **1**

After the macroscopic analysis of all fragments it was decided to determine crack growth rate within a stable crack growth range, starting at stage I of fatigue (initiation). Fig. 5 shows a fragment of the fracture being subject of the a.m. tests.

Fig. 5. Designations of fatigue sections of the wing skin specimen fracture for which of fatigue-growth bands have been counted, a – the appearance of the sections A and B of the fracture, b and c segments for which CGR was determined.

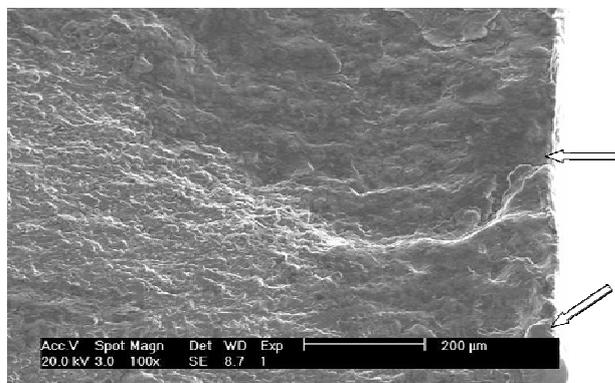
In the case of section A (fig. 5) the initiation of the fatigue crack started in hole 1 (fig. 4). In figure 5 distinct fatigue crack-growth bands can be seen. Fatigue origins are shown in figure 6. The standard methodology of microscopic examination was used. Only departure from the standard was choosing grains with crack direction identical with macroscopic crack instead of statistical measurements of crack growth rate in particular grains. On the surface of the hole traces of rivet interference were seen. At the distance of about 2 mm from the origin, the first blocks of fatigue striations have been observed (fig. 7). As it is shown in the figure, ten fatigue striations correspond to the step 1 (S1) of the load history, while 25 fatigue striations correspond to the step 2A (S2).

Fig. 6. Fatigue origins and fatigue zone in A section, near the hole 1. Two fatigue origins near the rivet hole can be seen.

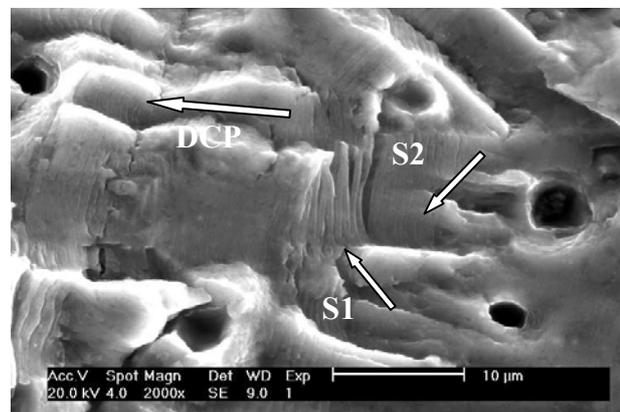
Fig. 7. Fatigue striations on the fracture of the specimen section A, at the distance of about 2 mm from the hole. DCP – direction of crack propagation, S1 – step 1 of the load, S2 – step 2 of the load.

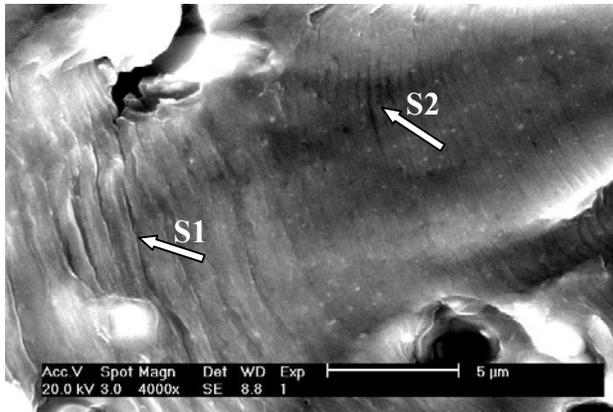
At the distance of about 4 mm from the origin, blocks of wider fatigue striations can be seen, what indicates an increase of crack-growth rate. On the enlarged figure 8, the wider fatigue striations correspond to step 1 of the load history, while 25 fatigue striations correspond to step 2A (S2). It was also seen that fatigue striations, which belong to the same load step have various widths and various directions, what testifies to different crack-growth rate in various grains of the material tested.

Fig. 8. Fatigue striations on the section A at the distance of about 4 mm from edge of the hole.

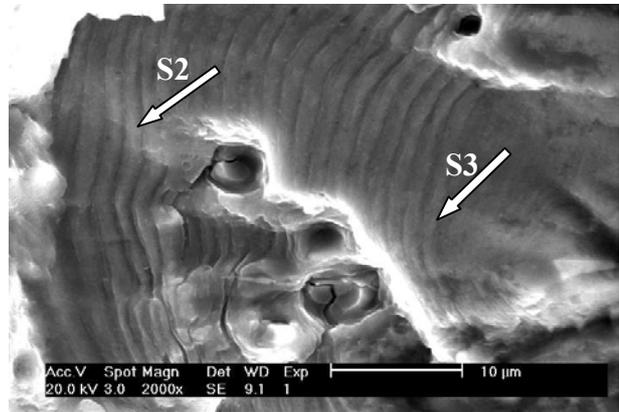
Farther from the origin, group of striations with higher spacing than these at distance of about 4 mm from the origin has been observed, what confirms the increase of crack-growth rate. The group of striations corresponding to step 1 of the load history is about 50 μm wide. In figure 9, group of striations, which corresponds to steps 2 and 3, is shown.

Fig. 9. Fatigue striations on the section A at the distance of about 14 mm from edge of the hole.

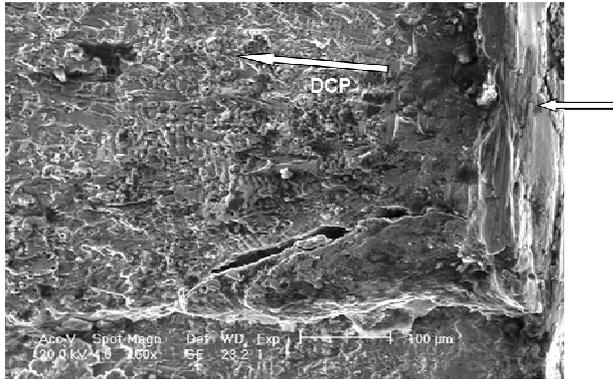
Next element on which fractographic analysis and identification with load history was performed is the section B of the fracture, shown in figure 4. In this case, the initiation of the fatigue crack also took place on the edge of the hole 1 (fig. 5). The appearance of the fatigue striations is similar to the ones in the section A.

Fig. 11. Fatigue origins and fatigue zone in section **B**, near the hole **1**.

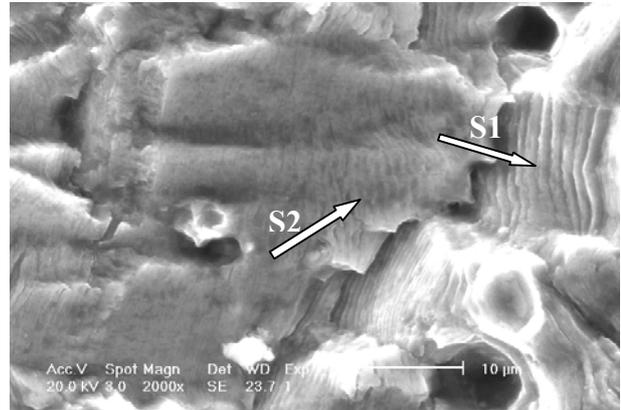
Fig. 12. Fatigue striations in the **B** section of the fracture, at the distance of about 2 mm from edge of the hole. Designations show the group of 10 striations corresponding to the step **1** of the load (arrow **S1**) and 25 striations corresponding to the step **2A** of the load (arrow **S2**).

occurring at stresses cyclic intensity being close to the value  $K_{IC}$  of metal<sup>6</sup>, p. 74. The photography of the section **B** (fig. 12) shows a smaller number of plateaus and a greater number of dimples than on the section **A**. It is the result of specimen stresses increase after **A** fracture.
