DAMAGE TOLERANCE DEMONSTRATION TESTING FOR THE AUSTRALIAN F/A-18

L. Molent¹, S.A Barter¹, P. White¹ and B. Dixon¹

¹ Air Vehicles Division, Platforms Sciences Laboratory, Defence Science and Technology
Organisation, 506 Lorimer Street, Melbourne, Victoria, 3001, Australia
e-mail: Lorrie.Molent@defence.gov.au
Web page: www.dsto.defence.gov.au

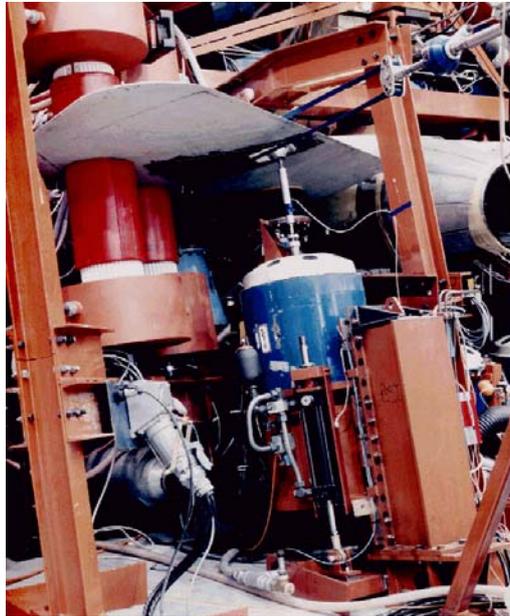
Figure 3: Rolling sleeve airbags (red) and electromagnetic shaker (blue) in place on the horizontal tail

The test system was developed during a five-year program utilising ST01, an early centre/aft static test fuselage provided by the USN. The availability of this test article was crucial to the development program, since it enabled the loading and control systems to be developed without risking the FT46 test article. The essence of the load application system was a unique rolling sleeve pneumatic actuator that has soft spring stiffness and low mass.

Using this system, the distributed manoeuvre loads were applied without affecting the effective stiffness and mass of the empennage components.

Concurrently, electromagnetic shakers applied the dynamic loading, while an active reaction control system maintained almost zero displacement of the test article tail area to minimise shaker stroke requirements during high manoeuvre loading. In this manner the significant number of dynamic cycles occurring over the service life of an aircraft was economically applied to a test article in real time. Combined closed loop operation of the air springs and hydraulic actuators was successfully developed. The controller developed at DSTO controlled 65 inter-dependant load channels such that the manoeuvre loads were controlled to within 2% of the required spectrum loads and the mode shapes and frequencies of the main control surfaces were maintained to approximately $\pm 5\%$ of those measured in flight.

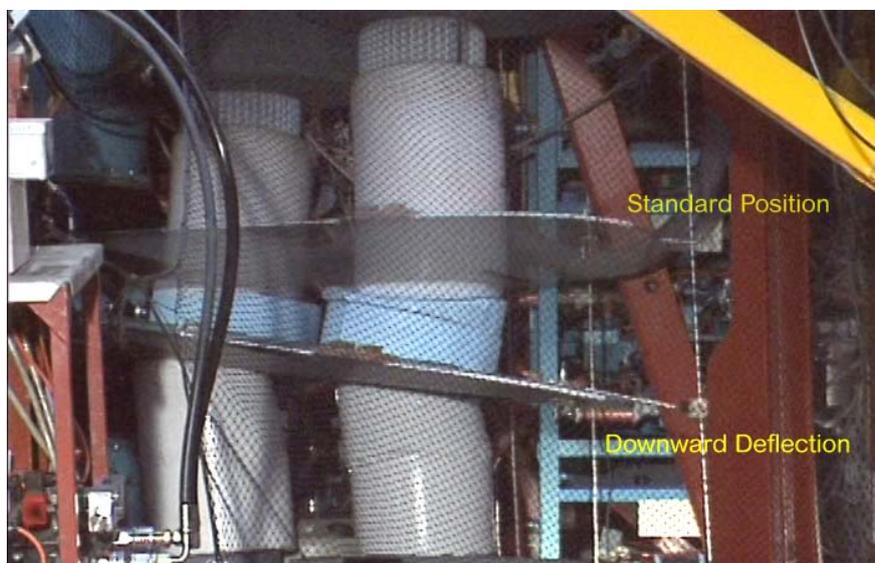
Figure 10: FT46 Stabilator at maximum down bending during FT46 RST.

The first phase of the RST was successfully completed in October 2002 (see Figure 10 for example of the deflection experienced by one of the stabilators). In order to further demonstrate the damage tolerance and/or fail-safety of the structure several more RST phases were conducted. Each phase introduced additional levels of damage from that existing at the end of cycling. This included the removal of several repairs and the simulation of up to two severed stubs (out of a total of 6) for a vertical tail. In some instances the fatigue cycling had

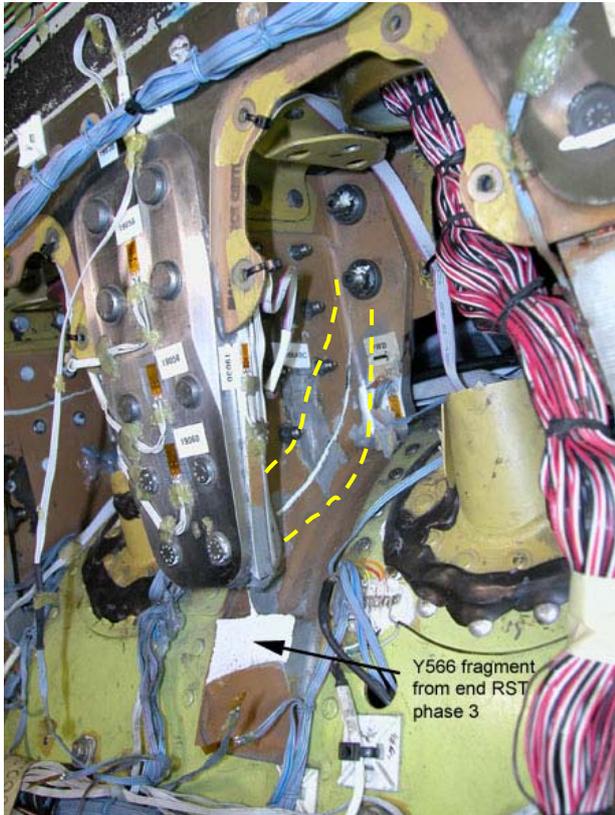
Figure 11: Overview of the failure of the Y566 stub at 79% RST load following simulated failure of the Y598 and Y590 stubs.

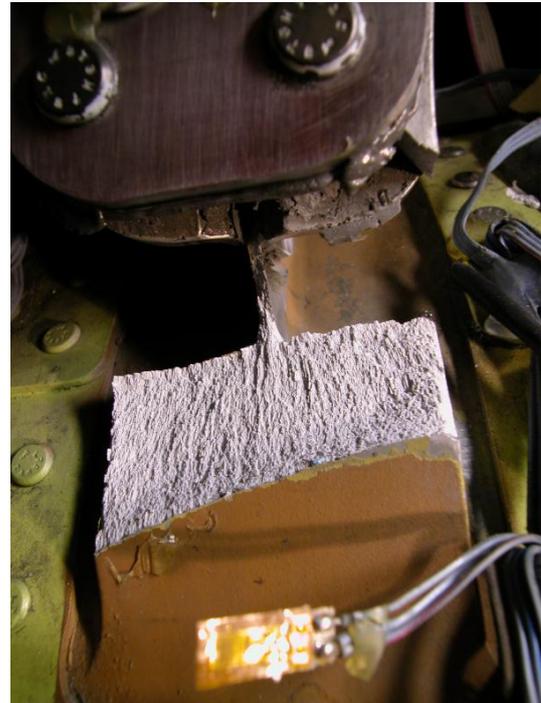
Figure 12: Close up of the expelled fragment location.
