## FATIGUE, RESIDUAL STRENGTH AND NON-DESTRUCTIVE TESTS OF AN AGING AIRCRAFT'S WING DETAIL

**Abstract.** *This study concentrates on fatigue, residual strength and non-destructive tests of an aging aircraft's wing detail of the Finnish Air Force's Hawk Mk.51 jet trainer. The studied detail was the integral stiffener with a drain hole near the wing root. Fatigue tests were deemed necessary to verify experimentally the analytically observed short fatigue life, significant crack growth rates and eventually to re-assess the detail's inspection period for the fleet jets. The results of the study have been utilized e.g. at the complementary type approval accomplished for the Finnish Air Force's Hawk.*

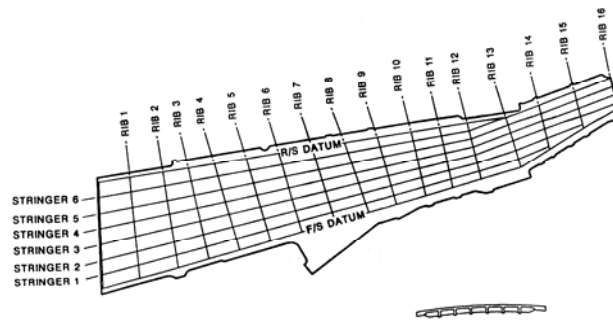
Figure 1: Numbering of the wing's ribs and stringer<sup>5</sup>

The small-scale specimens were cut out from stringers 1-4 between ribs 1-3 (Figures 1 and 2). The stringers, ribs and bottom surface of the wing form the integrated structure. The bottom surface side of the specimens was machined to constant dimensions. Finally the machined surfaces were polished. The holes were drilled for the specimens without any finishing treatment, thus corresponding better to real drain holes removed from sealing compound. The width, thickness, length and hole diameter of the specimens were about 20 mm, 6.7 mm, 280 mm and 5.1 mm, respectively.

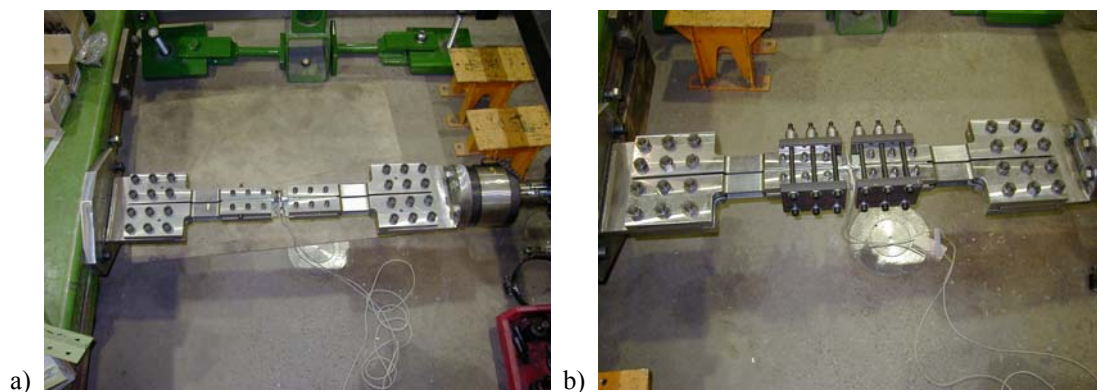
Figure 4: Fastening arrangements for the specimens STR4\_r a) and STR3\_r b)<sup>3</sup>

The component specimens were asymmetric (Table 2) and the bottom surfaces were slightly convex. For these reasons, special attention had to be paid to the load transfer to the specimens. To obtain the typical secondary bending level e.g. the fastening had to be adjusted from specimen to specimen (Figure 4). In Figure 4b the extra fastening arrangement was created in order to achieve sufficient friction to the stringer and thus a proper secondary bending. Naturally the adjustment of the secondary bending caused different prestressing conditions. Because of this the stress level at the bottom of the drain hole (6 o'clock) (Figure 3b) was aimed to be kept near the desired value and the possible errors were allowed to accrue at the top of the drain hole (12 o'clock).

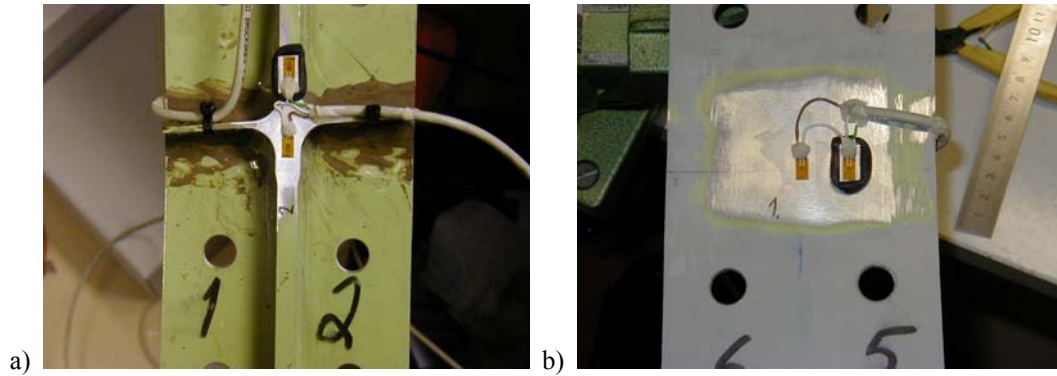
Figure 5: Strain gauges at the drain hole location: on the stringer (R2) a) and on the bottom surface (R1) b)<sup>3</sup>

The component tests were performed using an individual 250 kN hydraulic cylinder under load (force) control with INSTRON 8500 digital controller (Figure 4). The level of the cylinder force was controlled by strain gauges at the drain hole location: one on the stringer (R2) and the another on the bottom surface (R1) (Figure 5). The R1 strain gauge was used to control the cylinder and the secondary bending was specified by the R2 strain gauge.

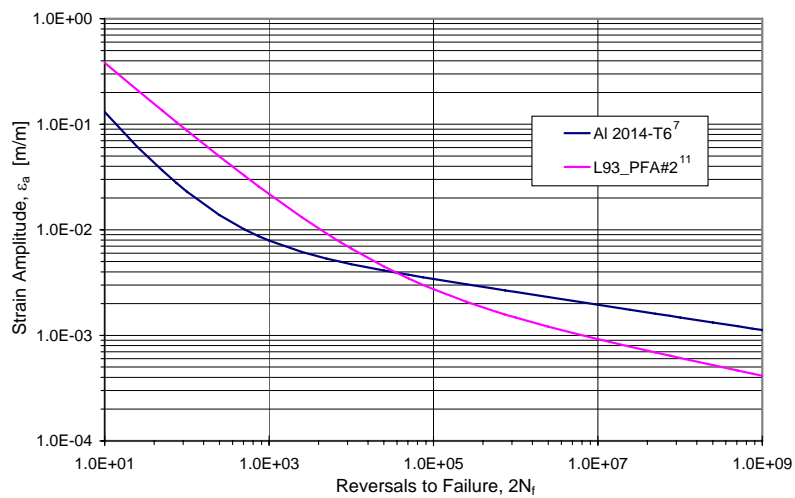
Figure 6: Strain-life curve based on the results of the small-scale specimens (L93\_PFA#2)<sup>11</sup>

Based on the test results the adjusted material data for the strain-life method are presented in Figure 6. The data for the aluminium 2014-T6 from the database of the MSC.Fatigue-program<sup>7</sup> are also presented in Figure 6.
