# DETERMINATION OF THE FATIGUE CRACK-GROWTH RATES FROM FRACTOGRAPHIC ANALYSIS OF SPECIMENS REPRESENTING AIRCRAFT WING SKIN

**Marcin Ciesielski<sup>\*</sup>, Jerzy Kaniowski<sup>\*\*</sup>, Włodzimierz Karliński<sup>\*\*</sup>**

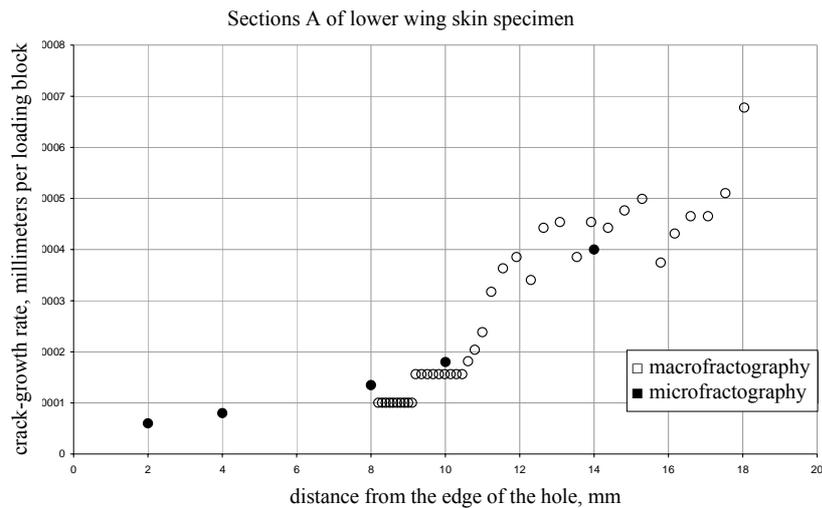
Farther from the origin, group of striations with higher spacing than these at distance of about 4 mm from the origin has been observed, what confirms the increase of crack-growth rate. The group of striations corresponding to step 1 of the load history is about 50 μm wide. In figure 9, group of striations, which corresponds to steps 2 and 3, is shown.

On the graph, fig. 10, crack-growth rate relation to the distance from the edge of the hole is shown.

Fig. 10. Crack-growth rate for the fragment A of the wing lower skin specimen fracture.

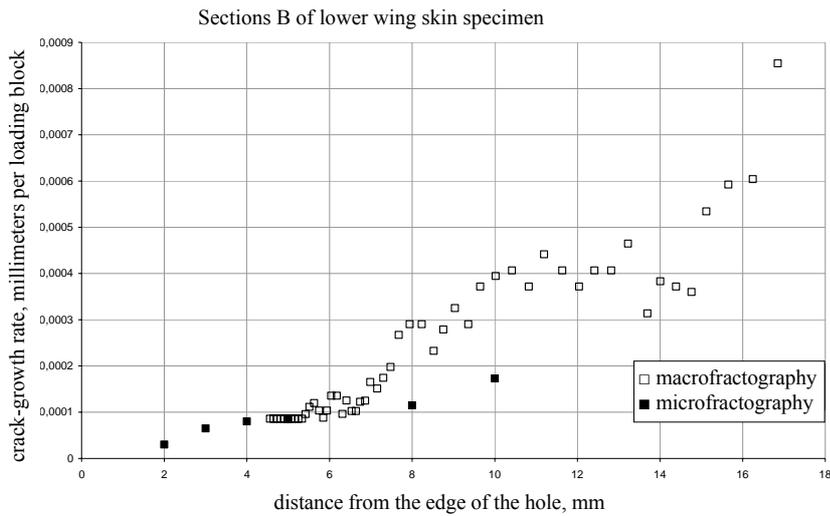
Fig. 13. Crack-growth rates for section **B** of the wing lower skin specimen fracture.

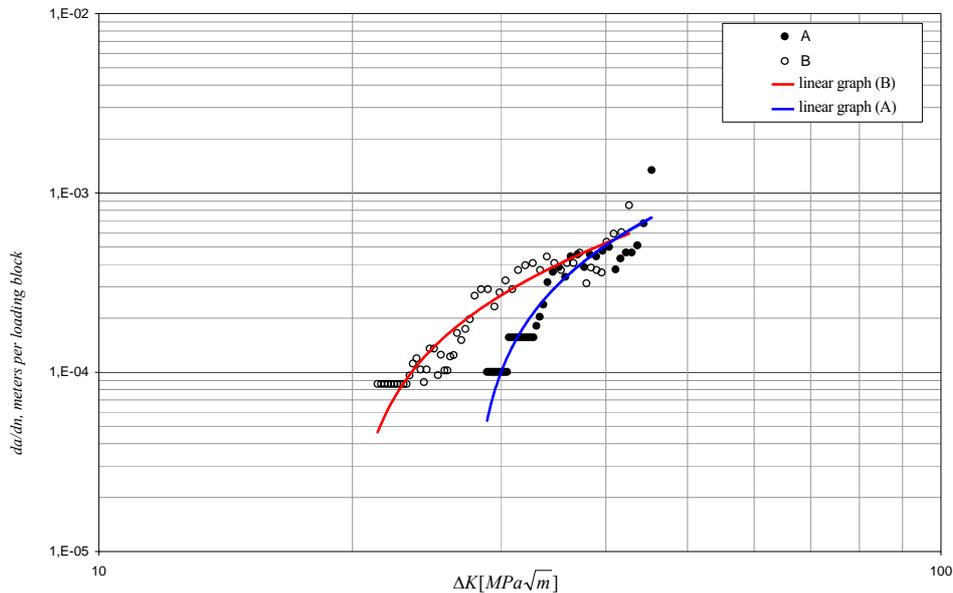
On the basis of the examinations for sections **A** and **B** of the fracture, relation of the crack-growth rate (expressed in millimetres per load history block) to  $\Delta K$  has been determined (fig. 14).

Fig. 14. Relation of the crack-growth rate to  $\Delta K$  for the sections **A** and **B**.
