2007 DTAS Keynote Presentation

Damage Tolerance

Facts and Fiction

International Conference on Damage Tolerance of Aircraft Structures

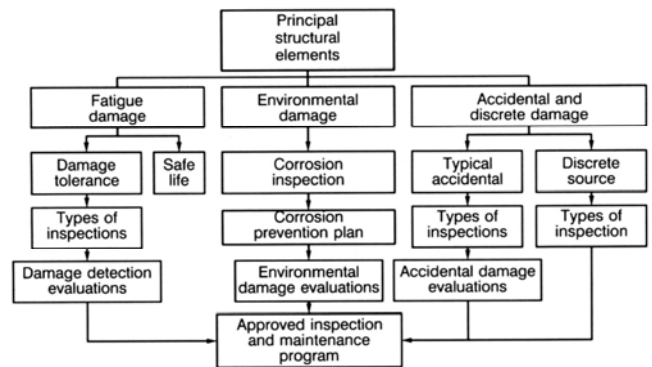
Figure 3. Principal Damage Sources for Maintenance Planning Considerations

- Crack Growth (Damage): The interval of damage progression from lengths below which there is negligible probability of detection to an allowable size determined by residual strength requirements.
- Damage Detection (Inspection Program): A sequence of inspections in a fleet of airplanes with methods and intervals selected to achieve timely damage detection. Structural inspection programs are typically developed by use of rating systems for each of the three major forms of damage, Figure 3.

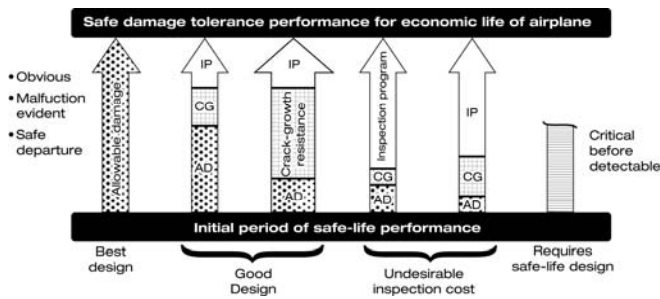
Figure 4. Interaction of Damage Tolerance Elements

The ability to analyze damaged structure has progressed significantly during the last twenty years through the evolution of fracture mechanics. Assessments now consider residual strength, damage growth, interactive multiple damage sites and quantitative structural maintenance evaluations. Figure 4 shows interaction of damage tolerance elements and the preferred design characteristics. The ability to use the emerging technology advancements has in the past been confined to relatively few specialists in the field of fracture mechanics. Boeing has developed damage tolerance technology standards suitable for use by large teams of structures engineers of varying levels of familiarity with fracture mechanics concepts.

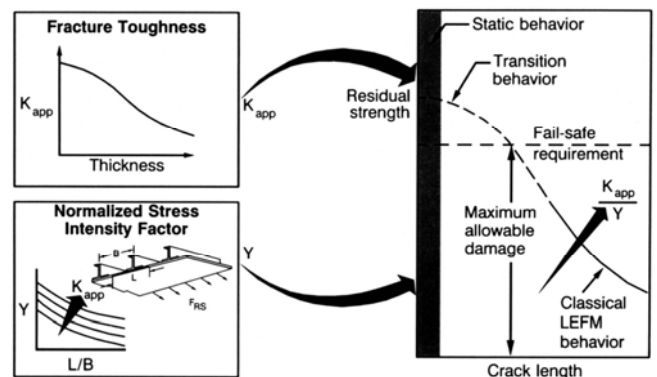
Figure 5 Residual Strength Technology Standards

Monolithic and particularly brittle material structures tend to conform closely to the traditional engineering methods of fracture mechanics. Built-up airplane structures consist of multiple sheet, stiffener, and fastener elements. Interaction between these cracked and uncracked elements causes significant redistribution of stresses. Failures are often precipitated by local exhaustion of plastic strain capability of the most critical elements, and/or net section failures involving a mixture of fracture mechanics and transitional behavior in some elements. Special failure criteria and deflection parameters are necessary to characterize the residual strength properties for damage levels ranging from short secondary cracks in adjacent details to larger primary cracks in details subject to inspection, Figure 5.

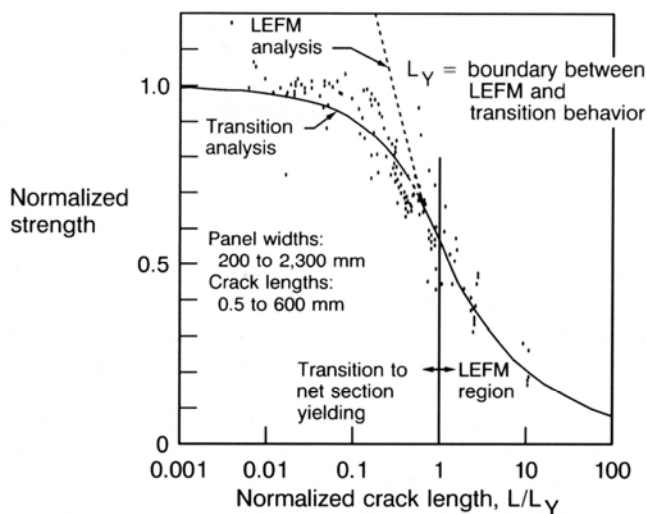
Figure 6 Residual Strength Test Verification Examples

A composite of normalized failure behavior plotted against crack length (L), normalized to the length beyond which linear elastic fracture mechanics applies (L_Y), is shown in Figure 6. An analytical representation of this behavior also is shown. The data for L/L_Y greater than unity were obtained primarily from center cracked panels fabricated from wing upper surface material, while similar data for wing lower surface materials fall in the transition region, belying their ductile behavior. The region near uncracked behavior was obtained by tests of 225 mm wide specimens containing small part-through or through thickness cracks.

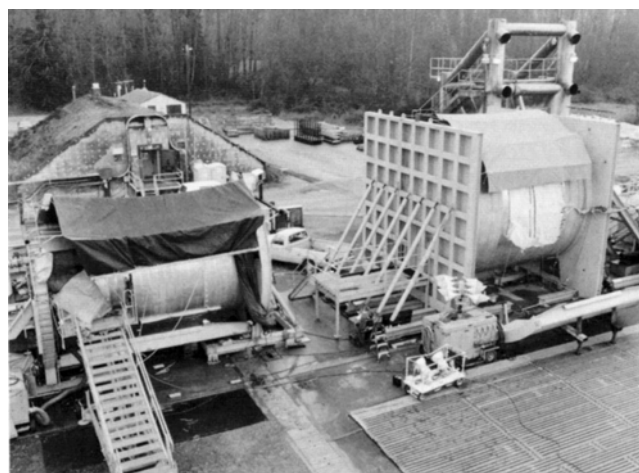
Figure 7. Fuselage Pressure Test Fixtures

In 1990 Boeing completed development of two large pressure test fixtures, one with an 1800 mm radius, representing a narrow body, and one with a 3200 mm radius, representing a wide body, Figure 7. These fixtures were designed to accommodate testing for fatigue, crack growth, and residual strength of large pressure panels with a variety of structural designs and details.

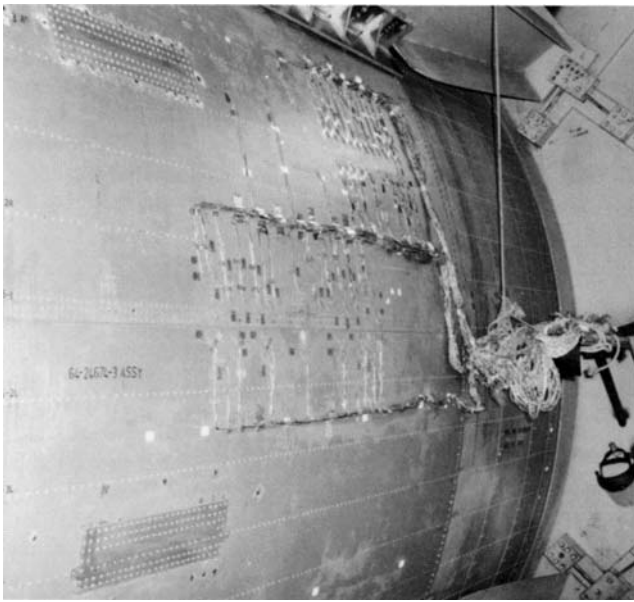
Figure 8. Typical Fuselage Pressure Test Panel

- At locations where fatigue cracks are likely to develop in a row of fastener holes, small cracks under approximately .5 mm at all holes can significantly reduce the residual strength of a large crack in the same row of holes.

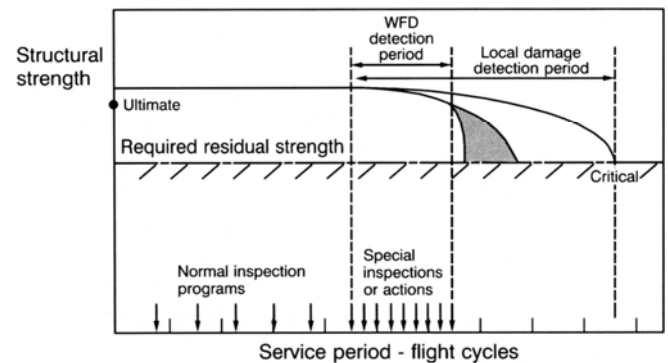
Figure 9. Damage Detection Comparisons for Local and Widespread Fatigue Damage

of widespread fatigue damage can significantly reduce these local damage containment areas. The safe damage detection period between the threshold of detection and limit load capability may also be reduced in the presence of widespread fatigue damage as shown in Figure 9.

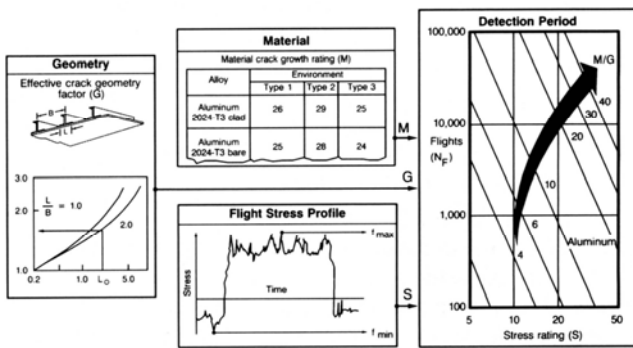
Figure 10. Crack Growth Technology Standards

Technology Standards. The rate of damage propagation is a function of material properties, structural configuration, environment, crack length of primary and secondary cracks, and operating stress exposure. Damage detection assessments require crack growth data from detection threshold lengths to the allowable damage determined by residual strength analyses. Use of normalized damage models for calculating relative growth per flight, including load sequence effects, permits separation of the material, geometry, and stress parameters. Solution of the G-integral for typical configurations in combination with material ratings, M, and stress ratings, S, provides the basic ingredient for efficient large-scale damage growth evaluations, Figure 10.

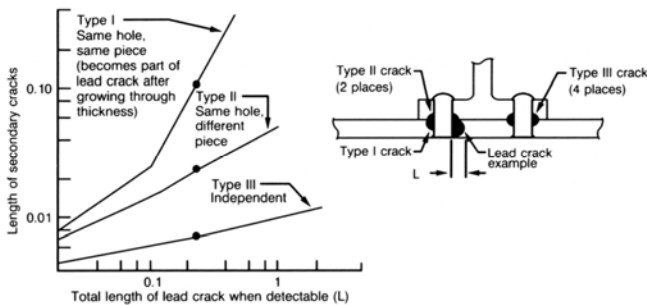
Figure 11. Multiple Site Damage (MSD) Size Analysis Guidelines

Numerous stress intensity solutions are required to evaluate typical cracking patterns in primary airplane structure. Dependent and independent crack size criteria have been developed based on detailed evaluations of typical configurations and verified by teardown inspections, Figure 11. Interactive growth of these cracks from detection threshold lengths must be performed based on configuration factors accounting for parameters such as edge margins, crack eccentricity, and crack-tip proximity to stress concentrations. A technique involving unit stress solutions is used to obtain equivalent stress intensities between initial and final crack lengths. These *G*-factors provide a convenient summary of more complex analyses performed once and assist the analysis with a quantitative measure for comparison of different cracking patterns.

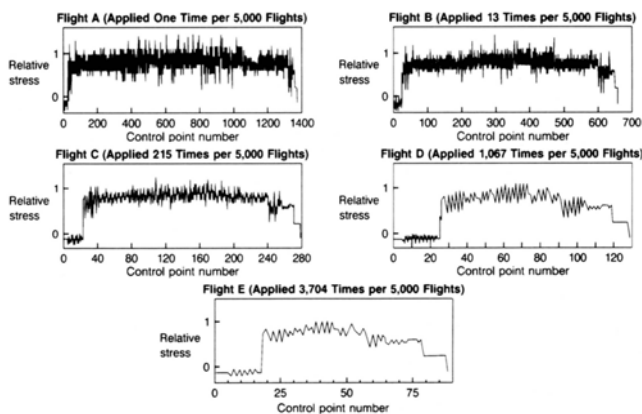
Figure 13. Wing Lower Surface Spectrum Example

The 5x5 and 10x5,000 spectra are random flight-by-flight test spectra that differ in the degree of randomization and the extent of low load omission and clipping levels. These spectra were developed using the same statistical criteria as the Transport Wing Standard Spectrum (TWIST) with special modifications that tailor the gust, flight, and ground load spectra for use on Boeing jet transport fatigue and crack growth evaluations. The 5x5 spectrum consists of five flight types randomly sequenced in repeated one-tenth lifetime blocks of flights. Five load levels are used in each segment of the spectrum to represent service usage. Examples of the flight types are shown for model 767 wing lower surfaces in Figure 13. Each flight consists of 50 load cycles on average. The 10x5,000 spectrum includes approximately twice as many cycles as the 5x5 spectrum and can use as many as ten load levels within a single segment.

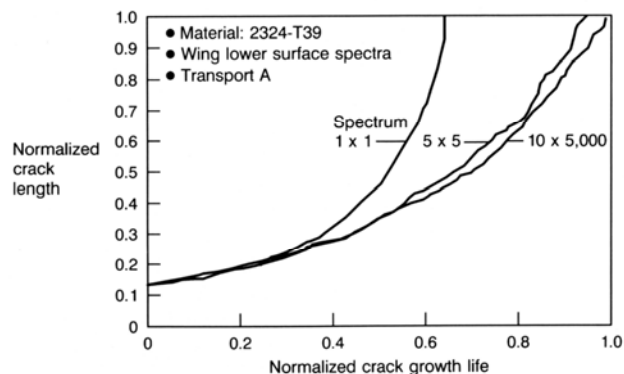
Figure 14. Effect of Spectrum Complexity on Crack Growth

Crack growth as a function of spectrum complexity is shown in Figure 14 for 2324-T39 plate specimens containing a central crack subjected to spectra representing loads on the wing lower surface of a commercial jet transport. Each of the three spectra was developed to produce the same damage based on an assumption of linear damage accumulation using constant amplitude test data. Crack lengths in most specimens were measured using two pairs of overlapping crack gages attached to opposite faces of the test specimen. Crack growth rates for the most sophisticated 10x5,000 spectrum and the simpler 5x5 spectrum are similar at all crack lengths. The crack in the specimen subjected to the 1x1 spectrum grew significantly faster at all crack lengths indicating that extensive simplification of a full spectrum of flight loads can produce misleading results. The relative crack growth performance of 2324-T39 plate specimens containing a central crack subjected to constant amplitude loading is shown in Figure 15. Each of the three specimens was machined from the same basic plate to a different thickness, nominally at the mid-plane of the plate stock. It can be observed that crack growth rates tend to decrease with decreased thickness. However, there is little difference at short crack lengths in the thinner gages. The relative performance for center cracked specimens of the same material and thickness, subjected to a wing lower surface spectrum, is also shown in this figure. A more consistent decrease in crack growth rate with decreased

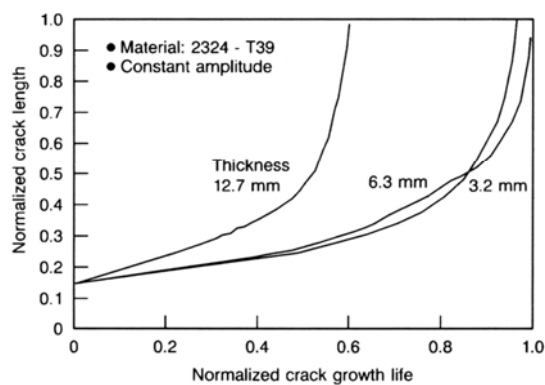
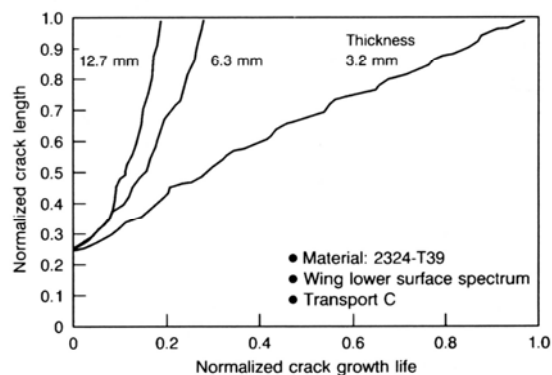
Figure 15. Thickness Effect of 2324 Aluminum Crack Growth

thickness can be observed. It is apparent that the influence of thickness is greatly enhanced under variable amplitude loading conditions.

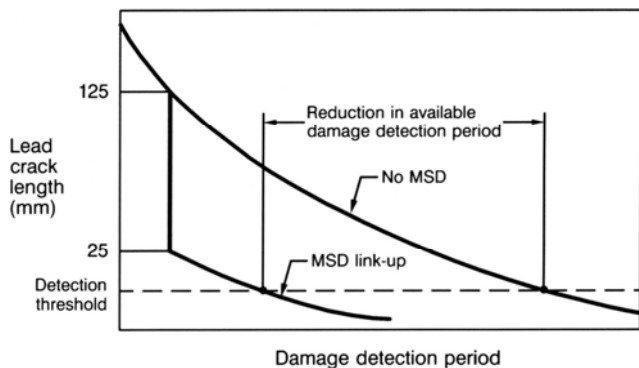
Figure 16. Multiple Site Damage Link-Up Effects on Detection Period

Multiple site damage concerns discussed previously under residual strength also prompted revisions of the technology standards in 1986 to address link-up of small cracks in fuselage lap joints. Data from lap splice and pressure dome testing demonstrated rapid link-up after the initial connection between two adjacent holes, Figure 16. This analysis approach was later incorporated in revisions of supplemental inspection programs. Subsequent testing of a 737 fuselage retired from service provided additional verification of the link-up process.

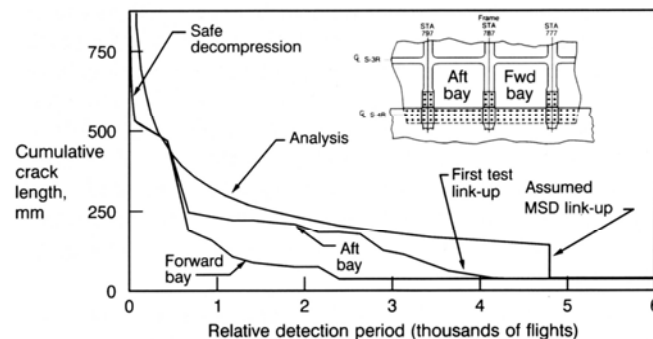
Figure 17. Test and Analysis Crack Growth Comparison for Fuselage Lap Splice with MSD Link-Up

natural conclusion of a two-bay crack with safe decompression by flapping. The loss of damage detection by rapid link-up is illustrated by Figure 17, and compares well with the link-up assumed in technology standards per Figure 16. In this test, MSD was present in adjacent holes and in adjacent frame bays with a nonuniform distribution of crack sizes typical of fatigue scatter. Although the test may not represent the worst case of fatigue scatter and MSD, it is reasonable to assume that the test results do represent typical performance.

Decompression by flapping is not relied on as a safety factor in the case of cracks in lap splices as discussed earlier. Rather, inspection programs must be in place to ensure crack detections before link-up. In the test described above, a 12 year damage detection period between initial detection and link-up was indicated assuming 3,000 flights per year. According to further experience on a fully disbanded in-service airplane, that number would be reduced to six years, still ample time for detection.

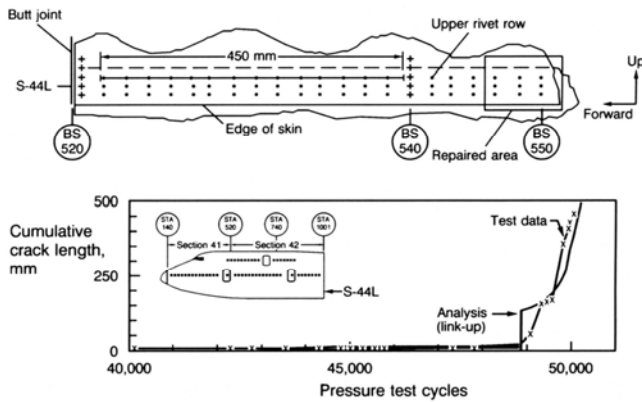
Figure 19. 747-400 Fuselage Lap Splice Test Results — Stringer 44L

The data also show that the 747-400 fuselage section is capable of supporting a one-bay crack, providing an additional safe crack detection period.

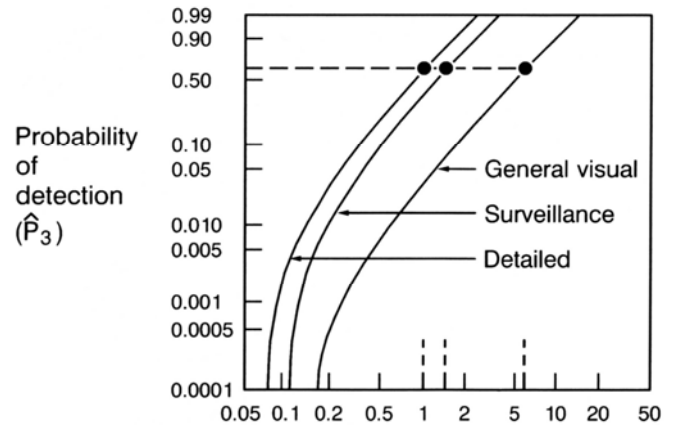
Figure 20. Relative Probability of Detection for Visual Inspection Methods

P_3 for visual inspections is based on an extensive review and analysis of fatigue cracks detected in service. Account has been taken of cracks remaining undetected during inspections prior to detection including those assumed to have occurred but not yet detected, Figure 20. Detection thresholds and characteristic crack lengths are defined by a three-parameter Weibull distribution.

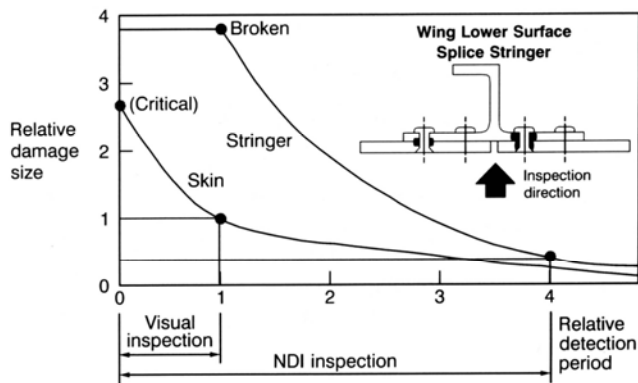
Figure 21. Visual Versus NDI Damage Detection Periods

Use of nondestructive inspection (NDI) procedures such as ultrasonic or low frequency eddy current may significantly increase the damage detection period, Figure 21. NDI procedures allow detection of smaller surface cracks than with visual inspection and also allow sub-surface crack detection. Therefore, an equal probability of detecting damage can be achieved with a reduced inspection frequency. Damage detection reliabilities have been established for different crack lengths in relation to the minimum detectable for typical inspection techniques and structural configurations, Figure 22. These P_3 curves are appropriately modified to account for visual detection of surface cracks and multiple probe applications at different locations along the same crack during the same inspection of subsurface cracks.

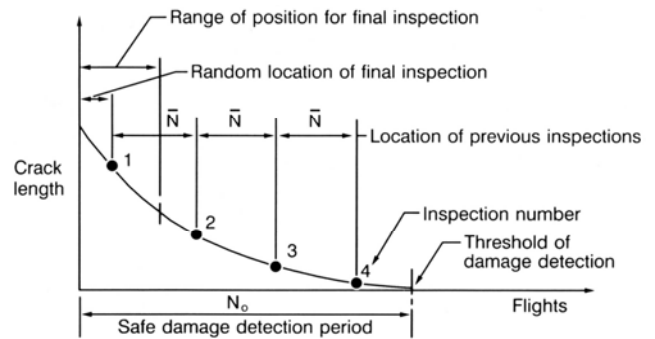
Figure 23. Multiple Inspection Detection Consideration

Crack length at the time of inspection is random. The last inspection occurs at some point during the final inspection interval, \bar{N} , Figure 23. Since P_3 varies significantly, the average value is determined by integrating individual P_3 over the interval. Previous inspection detection contributions can be approximated by the P_3 values for the midpoints of each inspection interval. The cumulative probability of crack detection in at least one of several inspections is $P_3 = 1 - \prod(1 - \hat{P}_{3j})$. In some cases the inspection interval \bar{N} is greater than the damage detection period, N_0 , and the probability that the inspection will occur is accounted for by calculating the average \hat{P}_3 for the inspection interval assumed equal to N_0 and using $P_3 = \hat{P}_3 N_0 / \bar{N}$ for damage detection assessments.

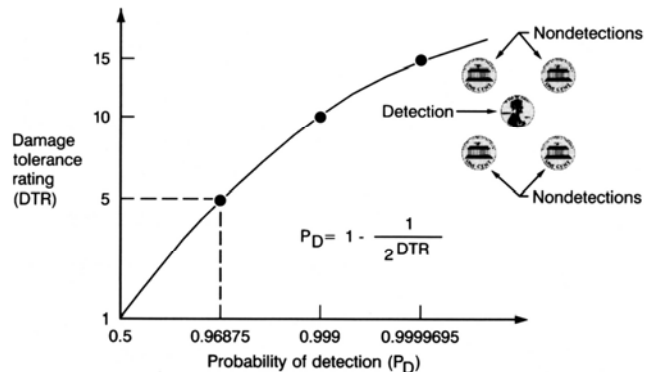
Figure 24. Probability of Detection Measurements

The measurement of detectability by DTR values provides a better comparison between P_D levels on a suitable engineering scale, Figure 24. The detection evaluation can be performed for varying inspection intervals and methods which are summarized on a form suitable for individual operator use, Figure 25.

Values of P_D such as 0.999 and 0.998 appear to be very close. If the probability of not detecting damage ($1 - P_D$) is considered, it can be seen that there is actually a 2-to-1 difference in these values. This provides a better comparison between P_D levels. To provide a direct qualitative measure of design and/or maintenance planning options, an equivalent number of 50/50 opportunities of detection is used to define a DTR discussed previously, Figure 24.

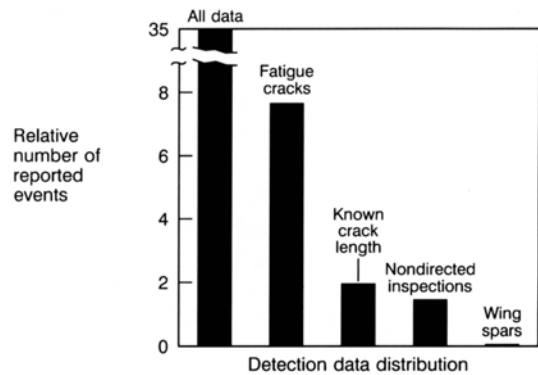
Figure 27. Relative Inspection Data Distributions

Reliability Reports (MRR) and Service Difficulty Reports (SDR), submitted by the operators to the Federal Aviation Administration and a Boeing internal Significant Item Report System (SIRS), have been used in an empirical evaluation of many of the parameters. The SIRS system contained over 35,000 events at the time of detection assessments in the early 1980s, and more than 7,700 related to structural fatigue. This information was used to isolate data with known crack length for areas with no prior cracking history in specific details, Figure 27. The distribution between directed and non-directed inspections was also accounted for. The MRR/SDR data base contained about 3,500 structural fatigue events and proved to be similar in most respects to the SIRS. The majority of cracks are found visually during non-directed inspections, Figure 28.

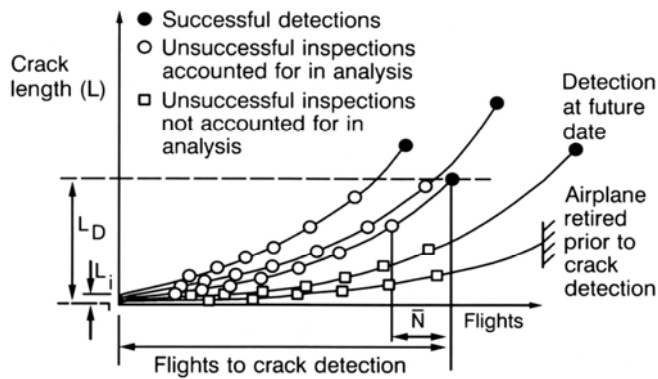
Figure 29. Detection and Nondetection Events

Detection standards used for fleet safety evaluations must recognize that many service inspections fail to detect damage beyond the detection threshold. A mean crack growth curve shape was used to describe the crack growth history prior to detection. Crack length, total flights at detection, and an assumed detection threshold after an appropriate period of service provided the necessary crack growth curve constants. Figure 29. Previous unsuccessful inspections correspond to non-detections that usually are 20 to 50 times more numerous than the detection events. Allowance was made for escalation in inspection intervals for the relevant period of collected service data and for cracks currently being missed that will be detected in the future. This latter point was demonstrated by successive

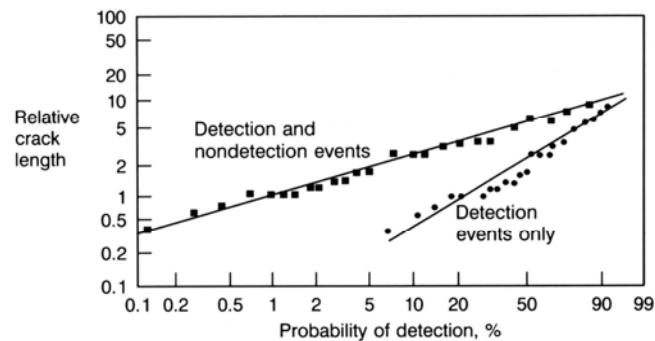
Figure 30. Effect of Nondetection Events on Probability of Detection

elimination of detection events and analysis of the reduced sample. The total influence of the non-detection events is substantial as illustrated in Figure 30.

Lessons Learned. The visual detection standards used by Boeing are based on a large fleet data base. Recognition of non-detection events significantly increases detectable damage sizes as illustrated previously in Figure 30. Subsequent experience with the DTR system to establish supplemental structural inspections has indicated that these detection standards do reflect existing maintenance practices. A further proof are the feasibility studies for fatigue inspections conducted for models 757 and 767 in the early 1980s. These programs emerged similar to past experience which would not have been the case for poorly calibrated detection standards.

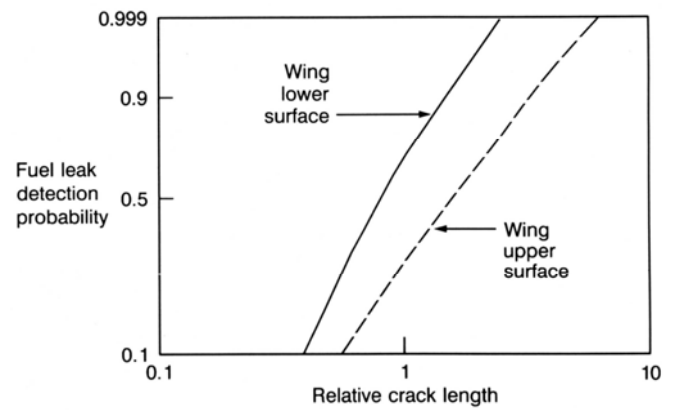
Figure 31. Probability of Fuel Leak Detection

The probability of crack detection as a consequence of a fuel leak was developed by evaluating cracks of known length reported in wet bay areas. Cracks found by fuel leak were isolated from those for which no leak was reported. The resulting sample of leaks and non-leaks was characterized using a Weibull distribution to give the probability of detecting a crack by fuel leakage as a function of crack length, Figure 31.

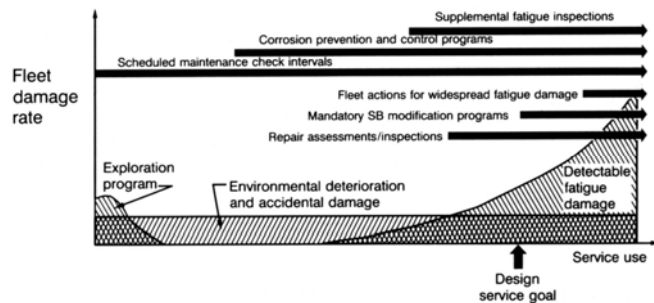
Figure 33. Fleet Damage and Maintenance Program Phases

Environmental deterioration and accidental damage are random events that can occur at any time, Figure 33. Inspection requirements related to these damage sources apply to all airplanes in the fleet. The threshold for inspection is the first scheduled maintenance check interval

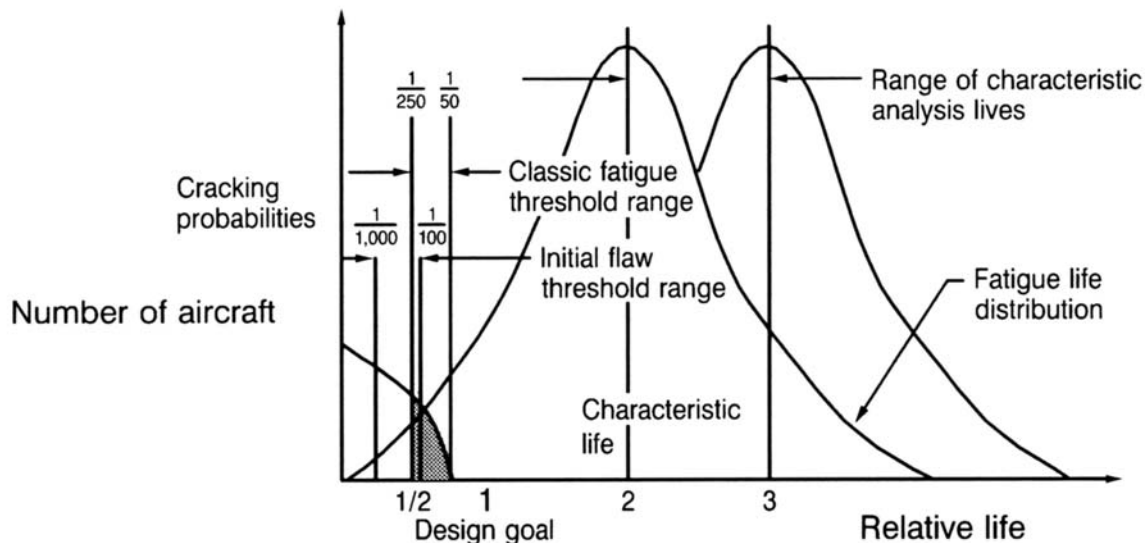
Figure 34. Threshold Examples Based on Classic Fatigue and Initial Flaw Concepts

initially developed more than ten years ago for the first generation of supplemental inspection programs. The rate of findings of previously unknown cracking does not support an often advocated abandoning of this approach in favor of initial flaw growth periods to critical factored by two. A couple of examples in Figure 34 shows the comparable thresholds by either method. While some provisions exist to adjust the initial flaw for inherent manufacturing quality and life enhancements, the end product of such assessments offer little advantage over service/test demonstrated fatigue initiation data. Figure 35 shows samples of initial flaws simulating typical structural fatigue details. A rogue flaw obviously implies different probabilities of occurrence depending on configuration and load transfer parameters.

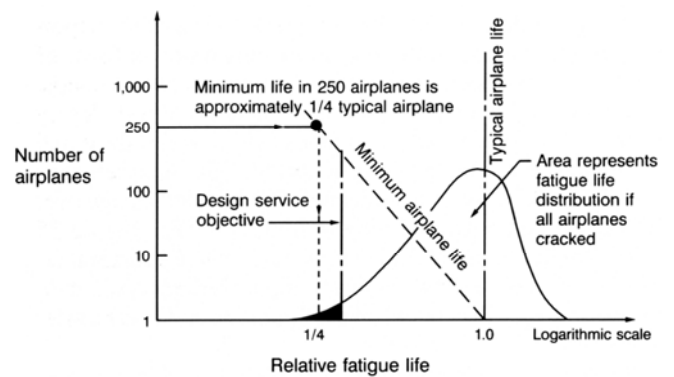
Figure 36. Variation of Minimum Life With Fleet Size

The order of occurrence of usage dependent fatigue damage is random in a fleet of airplanes. Airplanes with the highest number of flights, however, are most likely to experience the earliest damage, and supplemental inspections on fleet leader airplanes give the greatest benefits for damage detection in the fleet. The selection of candidate airplanes is described below.

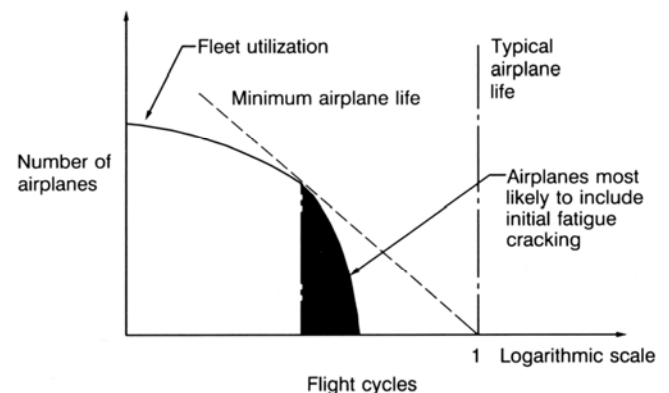
Figure 37. Fleet Cracking Order Based on Fatigue Life Distribution

The order of cracking is random and unique for each fleet. Airplanes with the highest number of flight cycles are most likely to crack first. The earliest cracking may occur when the fleet utilization curve meets the line defining minimum (first crack) life, Figure 37. Since the fleet size, production rate, and utilization are different for each fleet, a varying initial crack threshold results. The most likely group of airplanes to experience the initial cracking are those with more flight cycles than defined by this meeting point. These airplanes are suitable candidates for an aging fleet inspection program.

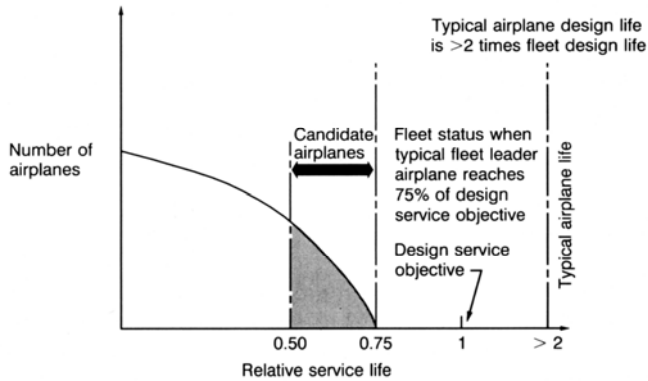
Figure 38 Supplemental Inspection Candidate Airplane Criteria

same life goal, Figure 38. Because the relationship between typical and minimum fatigue life is constant, the candidate fleet will not change unless there are significant changes in airplane distribution, composition, or utilization. The candidate population is therefore not changed as additional airplanes reach half of the design objective. This provides for a fleet leader population that moves with the total fleet and eliminates life thresholds that usually result in an increasing number of airplanes subject to supplemental inspection requirements.

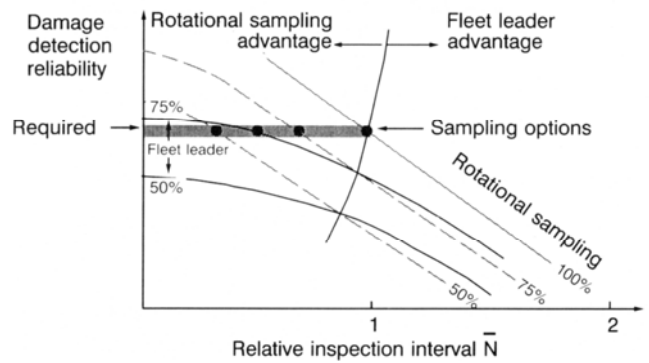
Figure 39. Fleet Sampling Options

Fleet leader sampling involves repeat inspections at regular intervals of a specified number of airplanes with the highest number of flight cycles in each operator's fleet. Rotational sampling involves inspections of a fraction of an operator's candidate fleet with a specified interval until all candidate airplanes are inspected at least once.

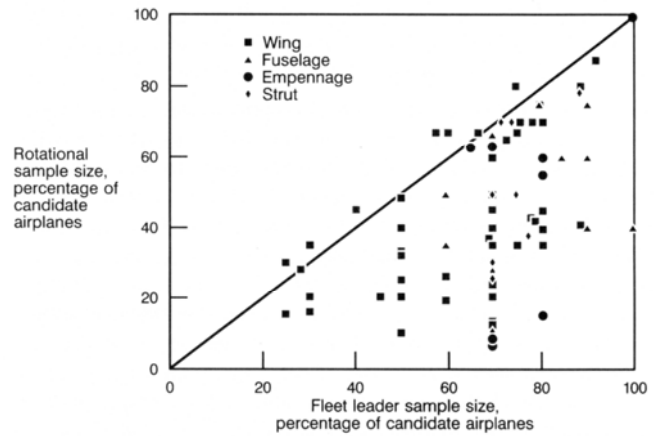
Figure 40. Fleet Sampling Efficiency Comparisons

Because the probability of inspecting a cracked airplane, P_1 , is less than one for fleet leader inspections, the attainable damage detection reliability is limited as the probability of detection P_3 is approaching unity for short inspection intervals, Figure 39. Evaluations of typical maintenance programs show very few cases where fleet leader sampling shows any benefits versus rotational sampling, Figure 40. These results are based on comparisons of the two sampling methods at a typical maintenance interval and required incremental detection reliability considerations. The fleet leader sampling option was therefore eliminated from the supplemental inspection program since rotational sampling provides for greater operator scheduling flexibility.

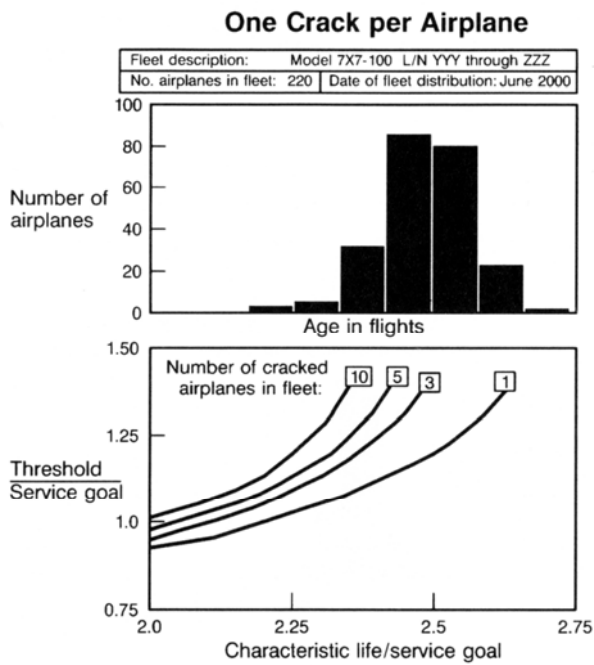
Figure 41. Fleet Service Cracking Estimate Example—One Crack per Airplane

Multiple Cracking Considerations. Typical inspection threshold determinations previously reviewed address local cracking in one or more airplanes. Continued operations of aging jet transports towards and beyond original design service objectives have prompted extensive industry actions to address widespread fatigue damage concerns. The simultaneous presence of Multiple Site Damage (MSD) or Multiple Element Damage (MED) offers additional challenges for proper selection of inspection thresholds.

Fatigue life distributions coupled with fleet usage characteristics can be applied to address inspection threshold selections. Figure 41 shows the inspection thresholds for different numbers of projected airplanes with single cracks in a major component. Figure 42 shows threshold estimates for varying numbers of cracks per airplane as well as number of assumed airplanes with cracks in the fleet. These projections can be determined for different calendar years to supply the engineer with estimates when structural and/or other corrective actions need to be implemented, Figures 43 and 44.

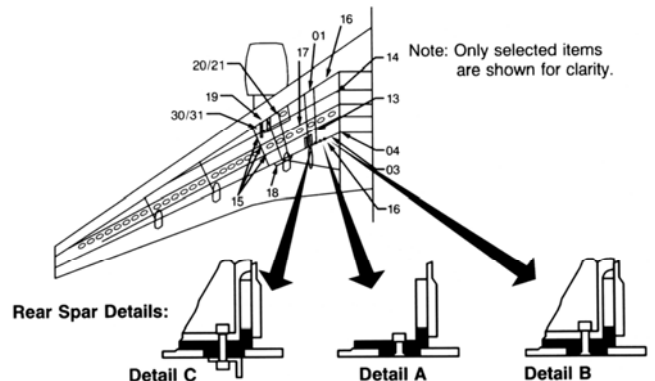
Figure 45. Structurally Significant Item Examples for Wingbox

regulatory levels or results in an unacceptable loss of function. Most SSIs require damage tolerance evaluations comprising residual strength for Category 2 structure and all three elements of damage tolerance for Category 3 structure.

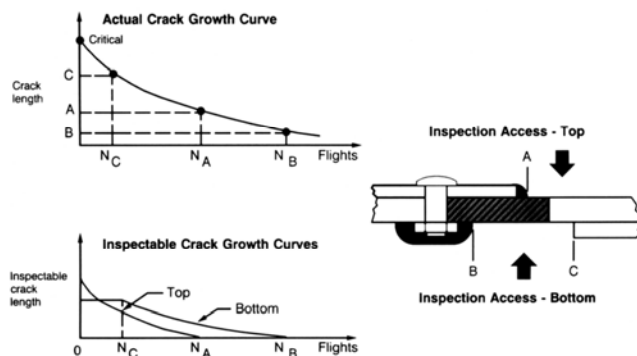
Figure 47. Inspectable Crack Length Considerations

The inspectable crack length at the time of inspection may be significantly different from the total crack length obtained by fracture mechanics calculations depending on several factors such as location of the cracks and direction and method of inspection. For example, consider the inspectable crack length for the detail shown in Figure 47. If inspected visually, the crack would be detectable past A or B, depending on the side of the detail inspected. The crack must grow far enough that the tip is beyond any obstruction, in this case the sheet and sealant on the top and the sealant over the fastener on the bottom. The inspectable crack length is zero when the tip clears the obstruction edge (locations A and B) even though the actual length is significantly greater. For inspections from the bottom of the detail after the crack tip reaches C, the inspectable length will not increase, because the crack past that point will not be visible.

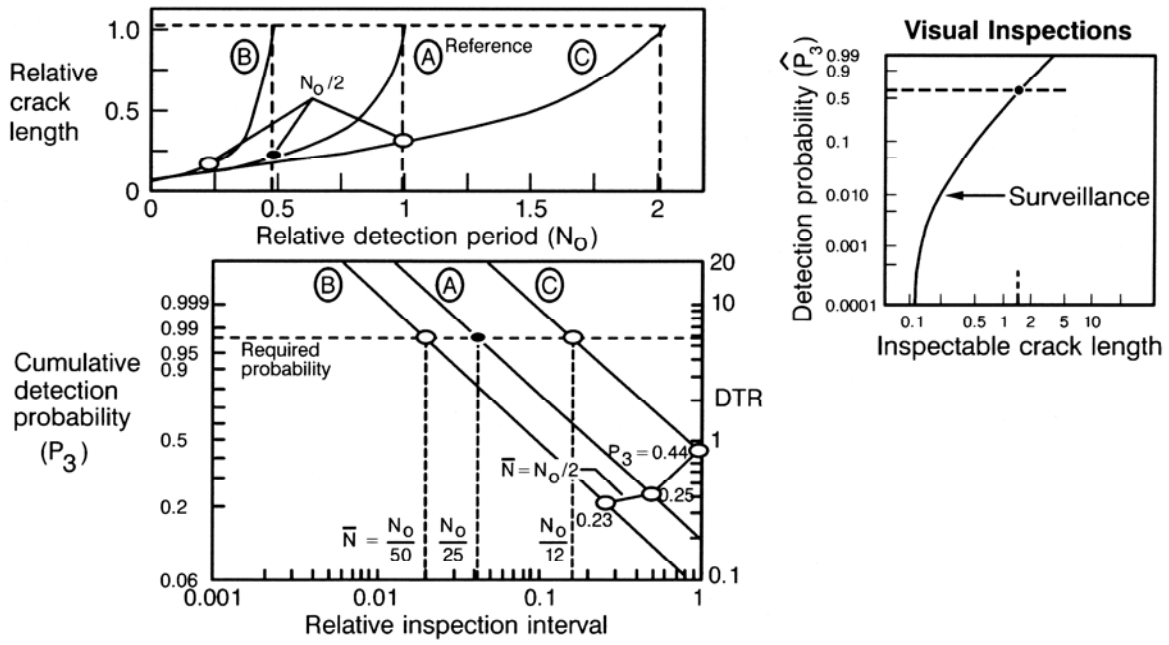
Figure 48. Cumulative Detection Probability — Detection Period Variation

The commonly used practice to set inspection intervals to half the damage detection period fails to provide a quantitative damage detection reliability. Figures 48 through 52 show cumulative damage detection probabilities under different combinations of damage growth characteristics and inspection options compared to results for inspection intervals equal to half the damage detection periods. It is apparent that required detection probabilities result in quite different inspection intervals compared to simple factoring of the detection period by two.

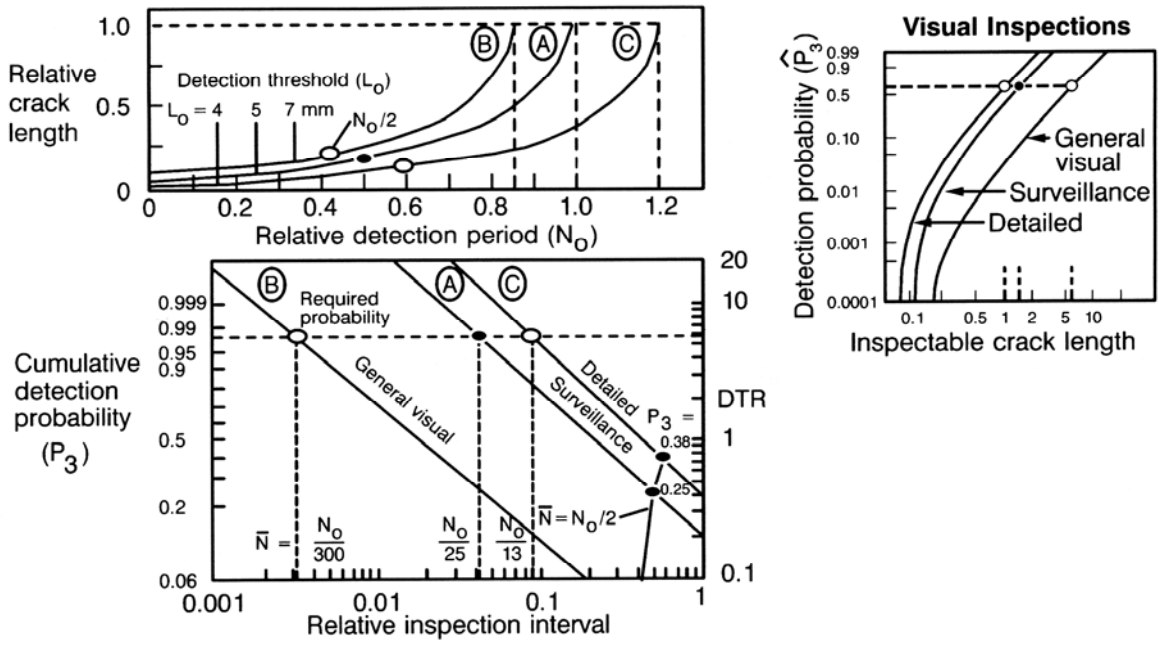
Figure 49. Cumulative Detection Probability — Critical Crack Length Variation

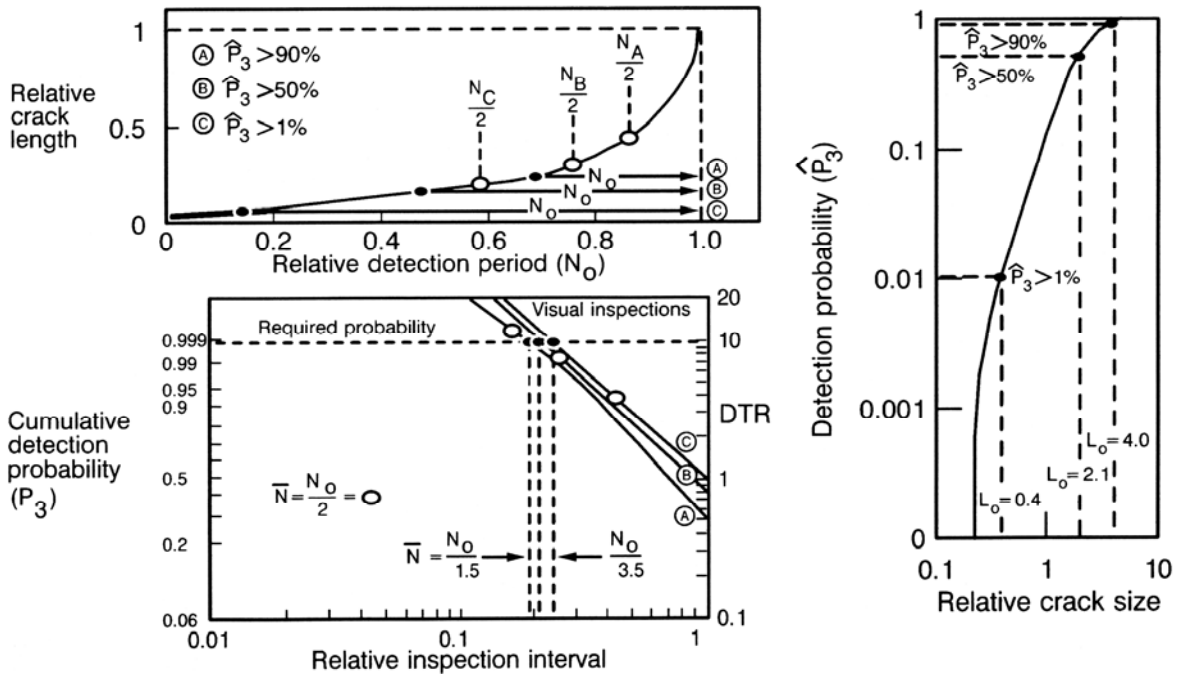
Figure 50. Cumulative Detection Probability — Inspection Type/Detection Threshold Variation

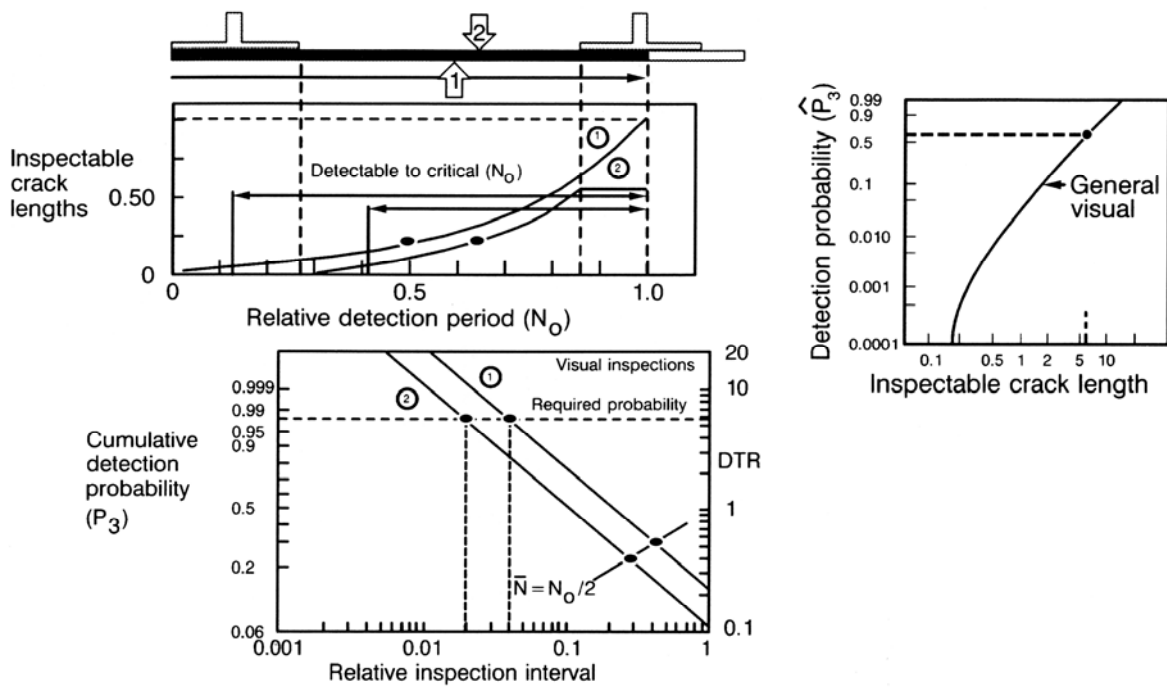
Figure 51. Cumulative Detection Probability — Detection Threshold Probability Variation

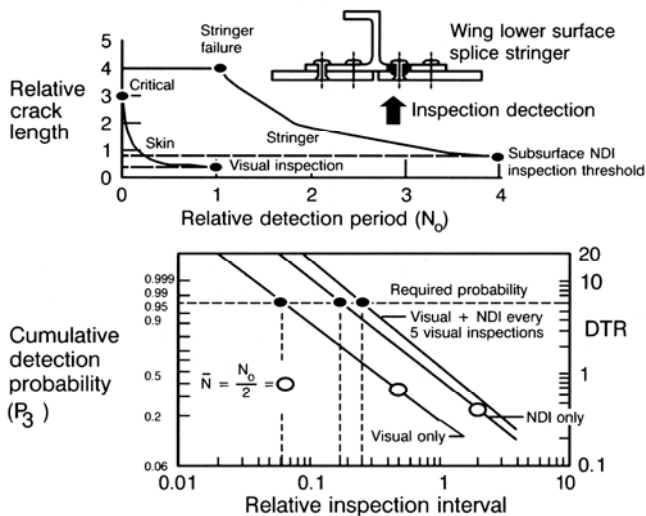
Figure 53. Cumulative Detection Probability — Inspection Method Variation

Damage detection requirements can often be met by a combination of visual and non-destructive inspections. Figure 21 shows a simple example of visual external inspections and/or external NDI inspections. Figure 53 shows the cumulative probabilities of detection for different combinations of inspections. It should again be noted that simple factoring of the visual or NDI detection periods by two gives quite different detection reliabilities.

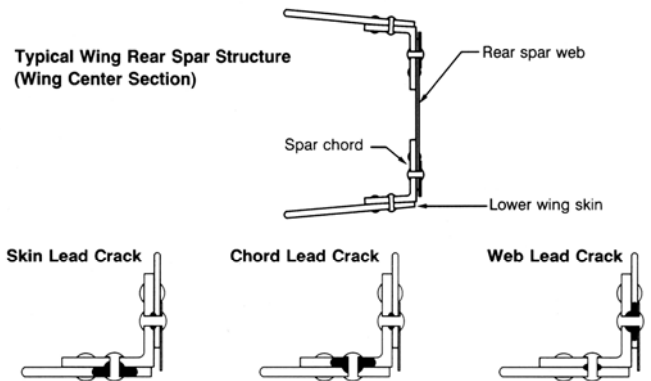
Figure 54. Wing Spar Chord Cracking Pattern Examples

Visual inspections can often be performed from different directions and the cumulative detection reliability must be derived accordingly. Figure 54 shows a wing center section rear spar example for different cracking patterns (lead crack assumptions). Actual and inspectable crack growth curves for directions 1, 2 and 3 are shown in Figure 55 for these three cracking patterns. Corresponding cumulative detection probabilities for different inspection options are shown in Figure 56. An example maintenance program providing sufficient detection probabilities is shown in Figure 57.

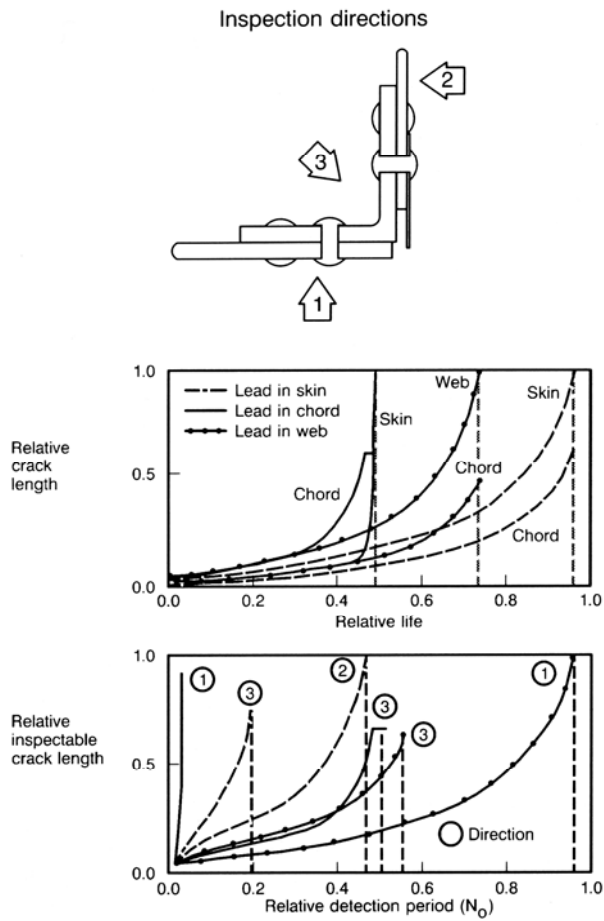
Figure 55. Spar Chord Crack Growth Curve Examples — Wing Center Section

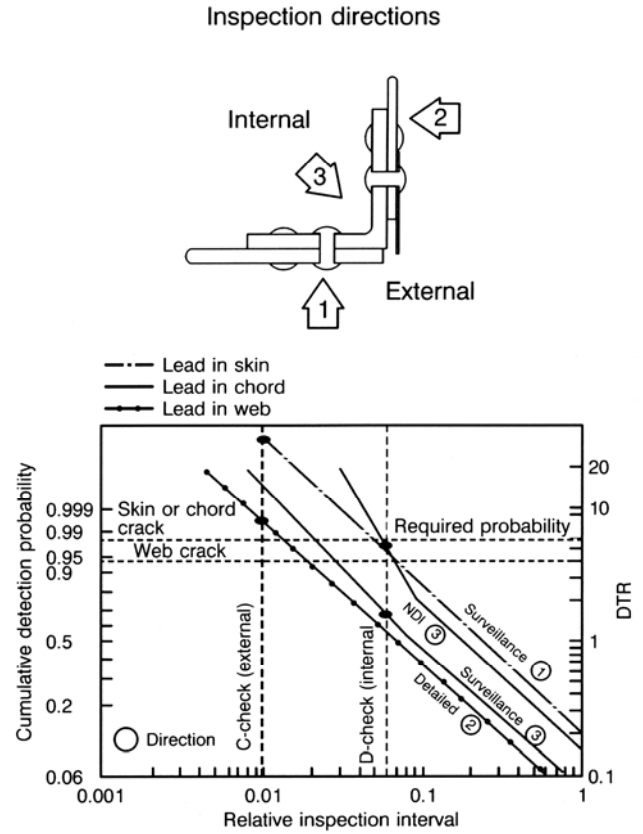
Figure 57. Cumulative Detection Probability — Cracking Pattern/Inspection Direction Combinations

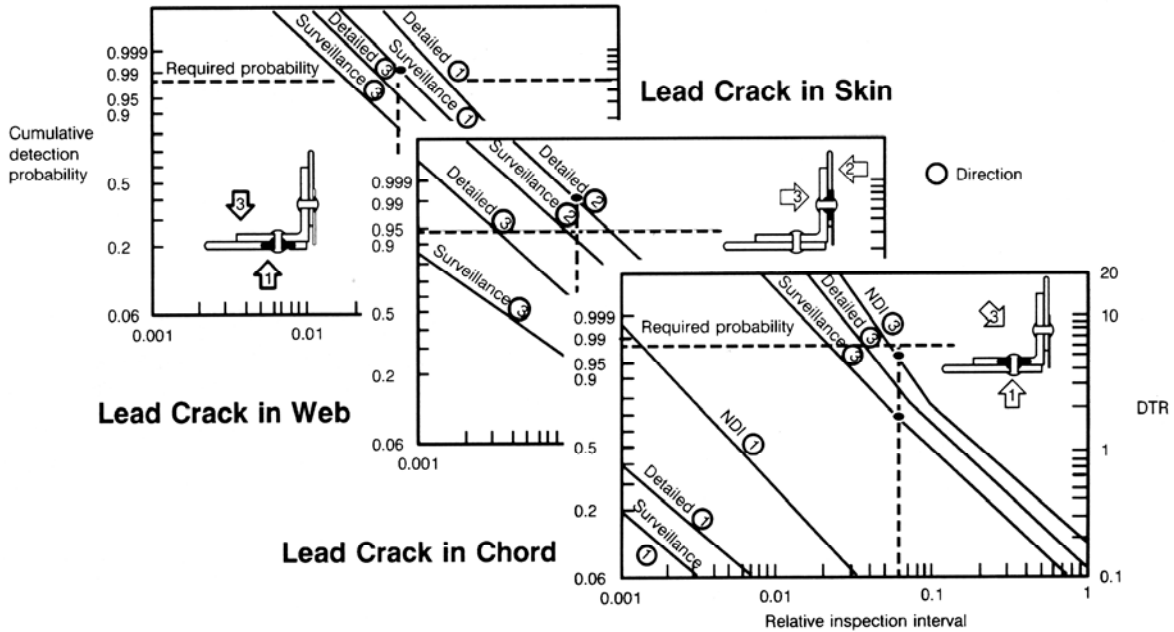
Figure 56. Cumulative Detection Probability — Cracking Pattern Variation

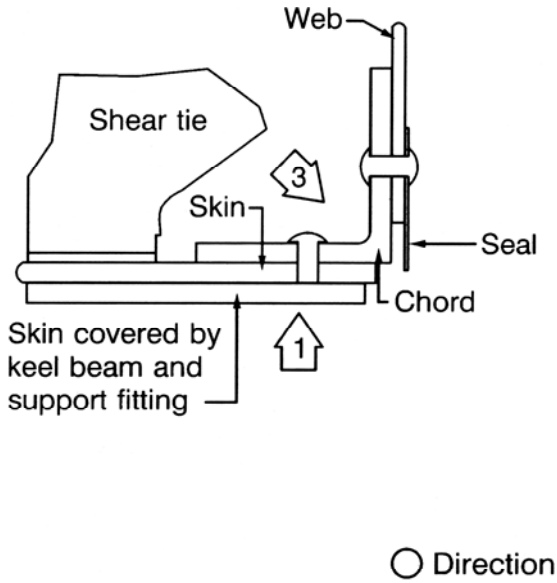
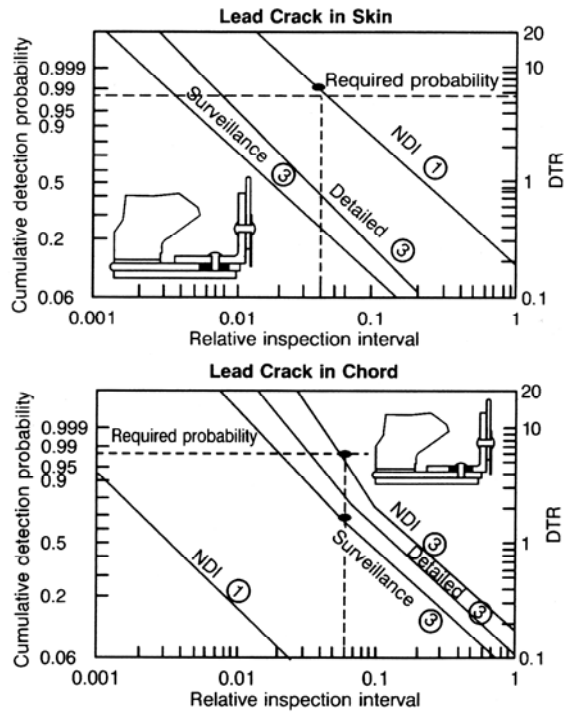
Figure 58. Cumulative Detection Probability Locally Hidden Skin Details

Figure 58 shows that the skin is covered by the keel beam at some locations which restricts external inspections. Such considerations must be made in the damage detection assessments to ensure that proper inspection intervals are selected. Web cracking is hidden by stiffeners as shown in Figure 59. NDI is typically required for such hidden details.
