2007 DTAS Keynote Presentation

Damage Tolerance

Facts and Fiction

International Conference on Damage Tolerance of Aircraft Structures

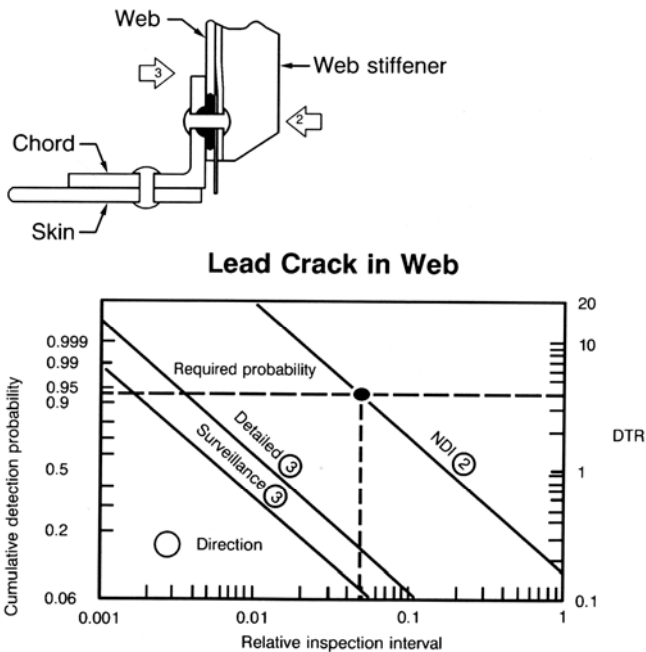
Figure 59. Cumulative Detection Probability Locally Hidden Web Details

Figure 58 shows that the skin is covered by the keel beam at some locations which restricts external inspections. Such considerations must be made in the damage detection assessments to ensure that proper inspection intervals are selected. Web cracking is hidden by stiffeners as shown in Figure 59. NDI is typically required for such hidden details.

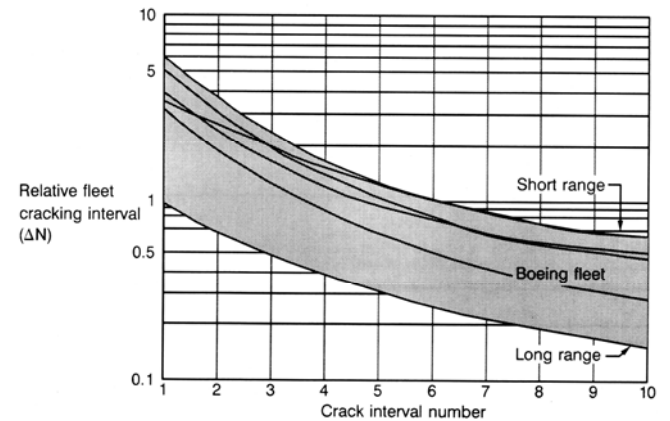
Figure 60. Fleet Cracking Variation — ΔN

Experience has shown that when damage is detected in the fleet, further inspections generally reveal additional damage in the same detail on other airplanes and/or on a similar detail at another location. Additional damage in the fleet increases the probability of detecting at least one crack. The number of flights between occurrences in the fleet of fatigue damage to the same detail, ΔN can be derived from actual fleet cracking statistics or from fleet usage and fatigue-life distribution, Figure 60. If the first damage is detectable at N_1 flights, the second damage will reach the same level of detectability at $N_1 + \Delta N$, and the third at $N_1 + 2\Delta N$, Figure 61.

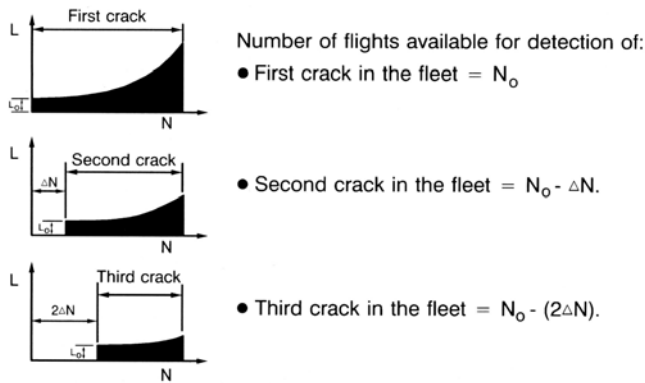
Figure 62. Multiple Fleet Cracking Contributions to Damage Detection

Each successive crack occurring during the damage detection period N_o , for the first crack, has a reduced interval for detection and a shorter crack length, Figure 62. Taking this into consideration, the cumulative probability of detection can be determined for each crack using the same procedure. From this the probability of crack detection in the fleet, using a given inspection method and frequency, as shown below

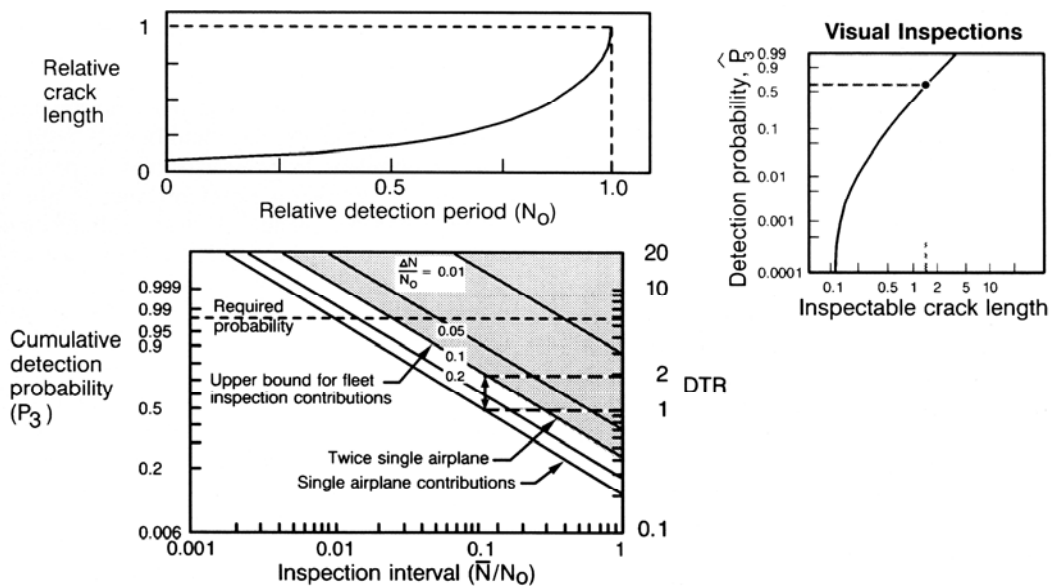
Figure 63. Cumulative Detection Probability — Fleet Inspection Detection Contributions

The relative contributions from fleet inspections in relation to the single airplane contribution must be considered to ensure that the total detection reliability is not achieved by long detection periods, N_o , and low individual airplane damage detection contributions, Figure 63. The total DTR for fleet inspection contributions is thus limited to twice the single airplane DTR contributions.

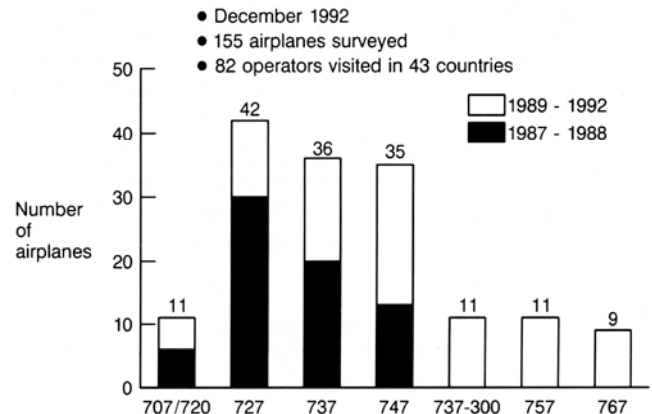
Figure 64. Boeing Fleet Surveys

Boeing initiated aging fleet surveys by engineering teams in 1986 to gain a better understanding of the condition of structures and systems and to observe the effectiveness of corrosion prevention features and other corrosion control actions taken by the operators, Figure 64. Boeing like other manufacturers continually reviews reported service data and other firsthand information from customer airlines in order to promote safe and economic operation of the worldwide fleet. These surveys were primarily prompted by the projected upward trend in airplane age towards and beyond original design service objectives.

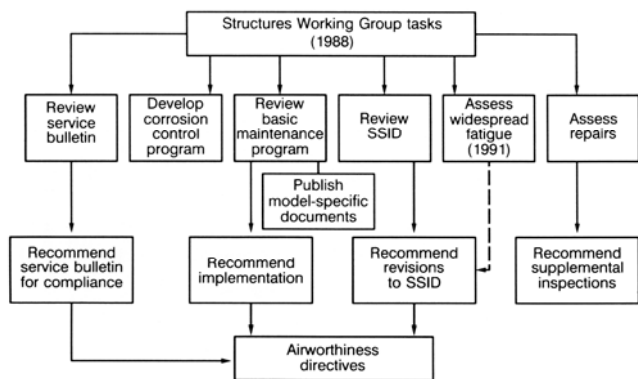
Figure 65. Industry Aging Fleet Initiatives

Extensive industry actions were initiated in 1988 to address aging fleet airworthiness concerns prompted by the explosive decompression of a 737 over Hawaii. Model-specific Structures Working Groups have demonstrated a cooperative determination over the last five-year period to make the right things happen within and across models and throughout the industry. The achievements have been impressive in the accomplishing of results in five original

tasks chartered by the Airworthiness Assurance Task Force, now known as the Airworthiness Assurance Working Group, Figure 65.

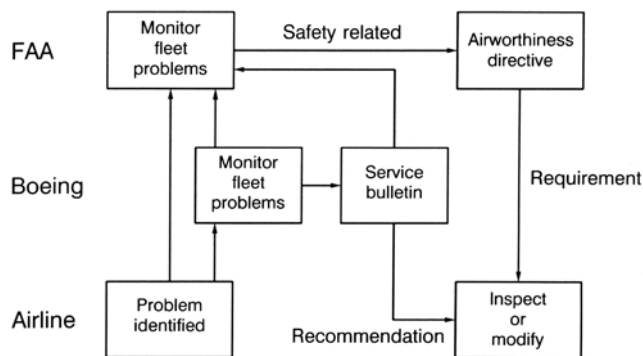
Figure 66. In-Service Problem Actions

Continuing airworthiness of jet transport structures designed to the fail-safe principles have traditionally been ensured by inspection programs. In the event of known, specific fatigue cracking and/or corrosion problems that if not detected and repaired, had the potential to cause a significant degradation in airworthiness, the normal practice in the past was to introduce a service bulletin, Figure 66. These bulletins defined inspection procedures (method, threshold and interval) which were designed to ensure with high (but undefined) degree of probability that the structural damage would be detected (and be repaired) before significant degradation in structural airworthiness occurred. Frequently these service bulletins would also specify modifications/rework procedures that would eliminate the cause of the cracking problems and provide an alternative to repetitive inspections as a means of ensuring continued structural integrity. The inspection parts of the service bulletins were sometimes mandated by means of Airworthiness Directives.

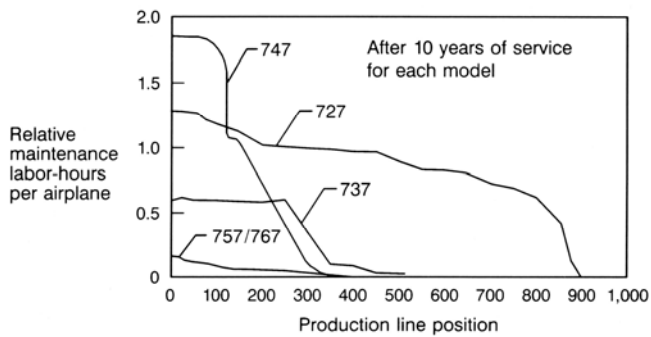
Figure 67. Comparison of Service Bulletin Labor Hours Related to Corrosion and Fatigue

It is important to note that cumulative service experience is incorporated in the design and reflected by less inspection/modification for later production units. In turn, these service experiences are incorporated in new models, often with orders of magnitude reduction in modification later efforts, Figure 67.

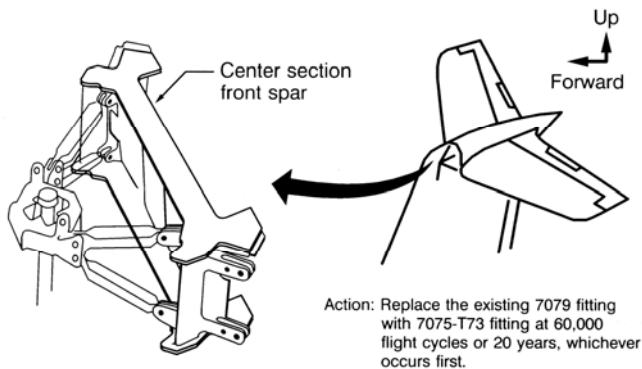
Figure 68. Mandatory Service Bulletin Modification Example for 727 Horizontal Stabilizer Front Spar Center Section With Stress Corrosion Problems

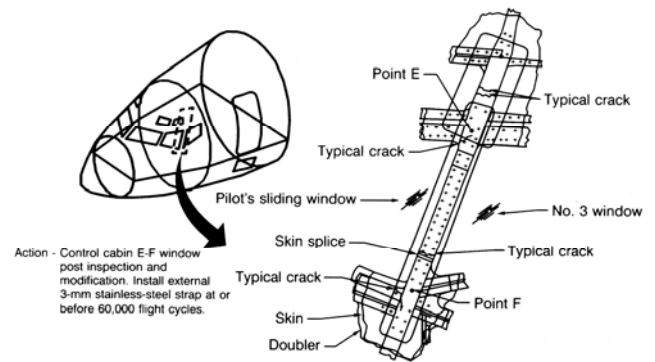
Figure 69. Mandatory Service Bulletin Modification Example for 727 Cab Window Post With Fatigue Problems

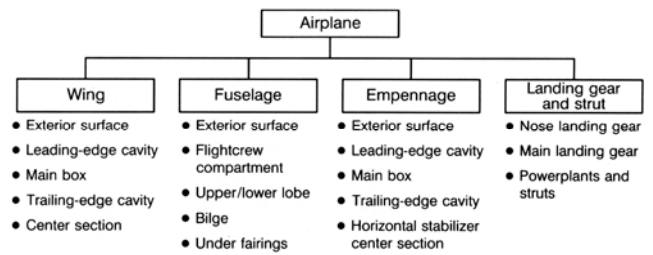
Figure 71. Corrosion Program Areas

The Boeing Corrosion Task Force reviewed all Boeing sources of information related to known corrosion problems. All problems relating to principal structural elements (PSE) were retained and segregated into selected general areas on the basis of having similar corrosion exposure characteristics and/or common inspection access requirements, Figure 71. Problems found to be significant in relation to continuing airworthiness were included in the program as specified tasks unless already covered by an existing airworthiness directive. It was recognized that corrosion growth rates varied widely, and it would be unduly conservative to establish a program based on the most severe operating environment. Therefore, the approach taken was to develop a baseline program that represented minimum requirements for typical operators. Individual operators who would experience significant corrosion after applying the baseline program must then modify or improve their program. The Boeing Corrosion Task Force developed a proposal for the baseline program based on existing recommendations, modified by current experience and knowledge gained by their review of available data.

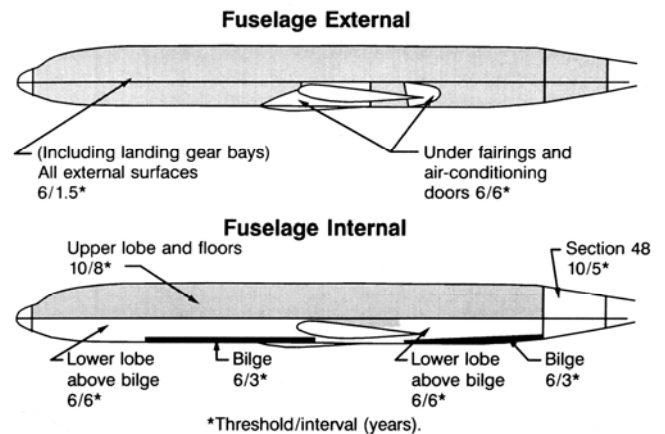
Figure 72. 727 Corrosion Control Program — Example

- External and internal inspections of all airplane structural areas are required at specified implementation times and repeat intervals. The program will require major opening up of the structure at these inspections. Figure 72 illustrates the required access to the 727 fuselage. It further details preventive measures including repair action and assurance that drain paths are clear, protective finishes are reapplied, and corrosion inhibiting compounds are applied.

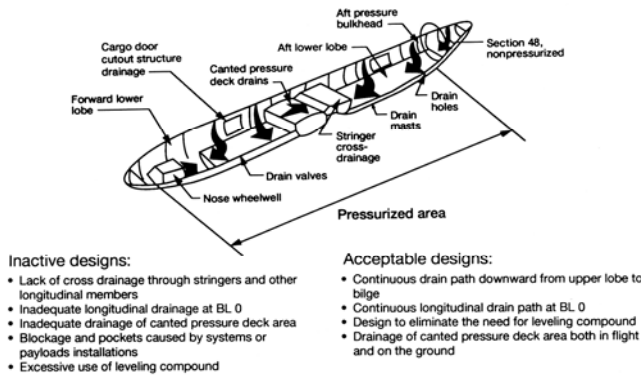
Figure 76. Lower Lobe Drainage Examples in Corrosion Prevention Design Handbook

Most structural behavior can be predicted and validated relatively quickly by analysis and static and fatigue testing. Corrosion behavior can only be confirmed by real time exposure. Consequently, we must rely very heavily on our historical experience, which has shown us that seemingly trivial details sometimes trigger major problems. Boeing has recently developed a comprehensive Corrosion Design Handbook reflecting fleet experience to provide the structural engineer with the same corrosion prevention expertise that parallels methods used to develop producible, durable and damage tolerant structures, Figure 76. While many corrosion problems were addressed in durability design guides, it became apparent from fleet surveys and service experience that a separate and dedicated corrosion prevention resource guide would be more effective. Similarly, improved structural arrangements and concepts will enhance the inherent robustness and forgiveness of the structure, facilitate simpler repairs when damage occurs, and facilitate accessibility and inspectability. The 777 program placed strong emphasis on these issues as the design concepts were finalized.

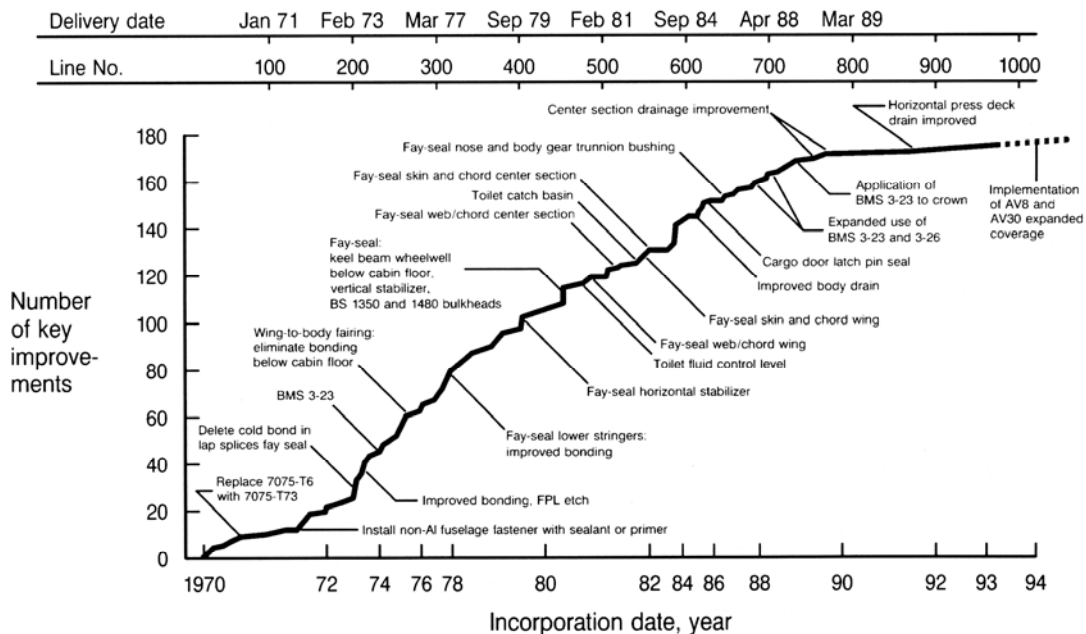
Figure 77. 747 Corrosion Prevention Design Improvement Effects on Service Performance

Many corrosion-related improvements in materials, finishes, processes, and design details have been introduced into the production lines of all existing and new models, Figure 77. These changes were expected to significantly reduce the corrosion problems typically encountered later in service. Figure 78 compares cumulative corrosion events reported by the operators for the pre- and post-improvement 747 airplanes after approximately the first ten years of service. The apparent results are dramatic and very encouraging. However, before becoming too confident of our success, we must be sure that the data represent true airplane condition rather than the results of a relaxed, overconfident reporting system. Consequently, the Boeing Airplane Fleet Survey program was expanded to include surveys of ten-to twelve-year-old airplanes to determine firsthand knowledge of which of these improvements are really proving effective in typical service use. Such data are essential to benchmark our current standards and to develop the proper baseline and objectives for new design and current production models alike.

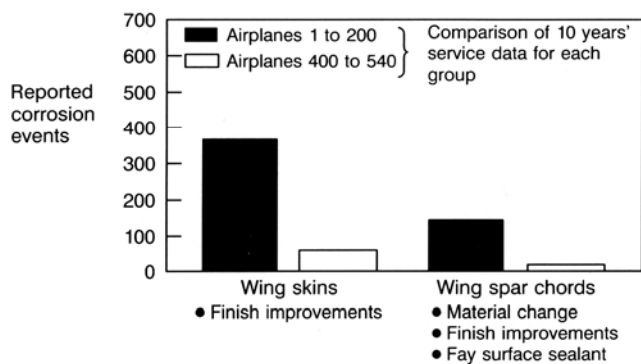
Figure 78. Corrosion Prevention Design Improvements Examples — Model 747

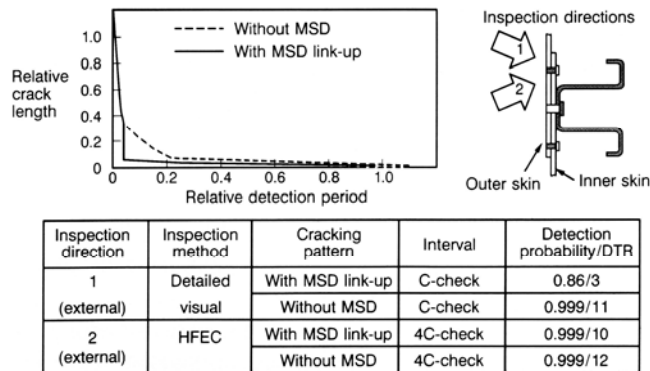
Figure 80. Example of SSID Revisions to Account for Assumed MSD Link-Up in Lap Splices

reduced time frame to safely detect the cracking. The SWG concurred that the SSIDs should include considerations for structure susceptible to that form of cracking with appropriate changes of damage detection periods and inspection intervals. Figure 80 shows examples of impact of MSD link-up on damage detection periods and associated cumulation detection probabilities.

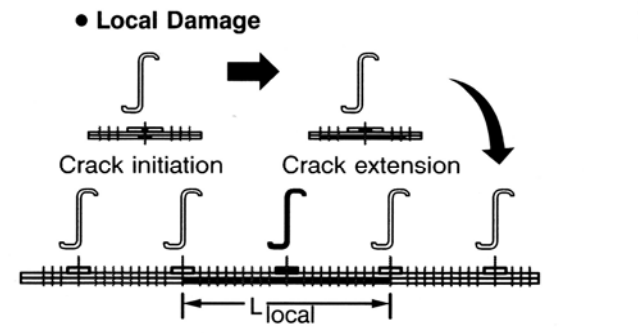
- Maximum allowable damage shown
- Damage connection up to this size is tolerated
- No significant damage beyond this region
- All MSD or MED within this area is local and already accounted for in damage tolerance analysis

Dependent types of MSD and MED that are within the extent of existing damage tolerance regulation compliance assumptions are labeled “local.” Such dependent damage is characterized by retention of residual strength capability after link-up of adjacent finite cracks. Independent types of WFD may reduce the residual strength and corresponding critical crack length substantially, Figure 81.

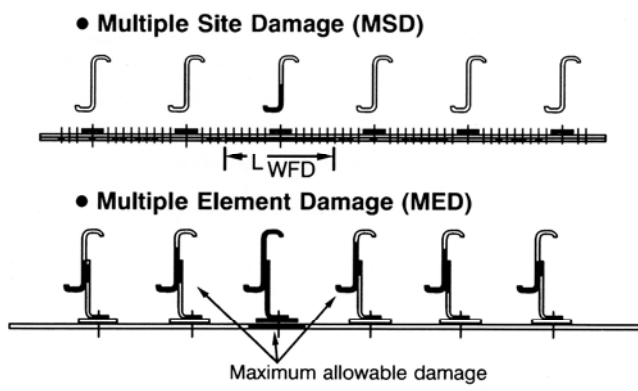
Figure 81. Example of Local Versus Widespread MSD or MED

- Widespread similar details
- Similar stresses
- Structural interaction with reduced allowable damage

The concern for WFD thus exists when large regions with similar structural details and same significantly high stress levels. Coalescence of multiple damage origins may potentially be catastrophic, and there is a lack of confidence in damage detection before such unsafe conditions may develop.

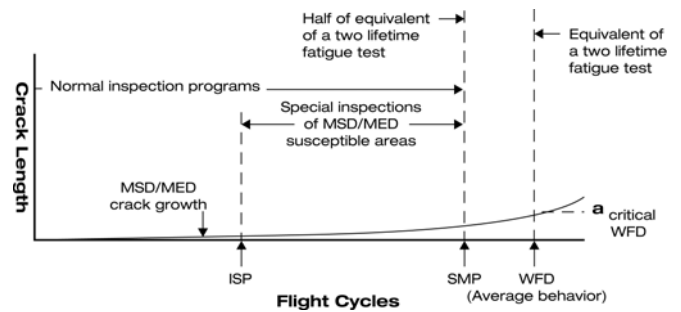
Figure 85. ISP and SMP Graphical Representation

Inspection Start Point (ISP): is the point in time when special inspections of the fleet are initiated due to a specific probability of having a detectable MSD/MED condition.

Structural Modification Point (SMP): is a point reduced from the WFD average behavior (i.e., lower bound), so that operation up to that point provides equivalent protection to that of a two-lifetime fatigue test. No airplane may be operated beyond the SMP without modification or part replacement.

The AAWG Guidance material requires determination of the following information for each MSD or MED susceptible area, Figure 85.

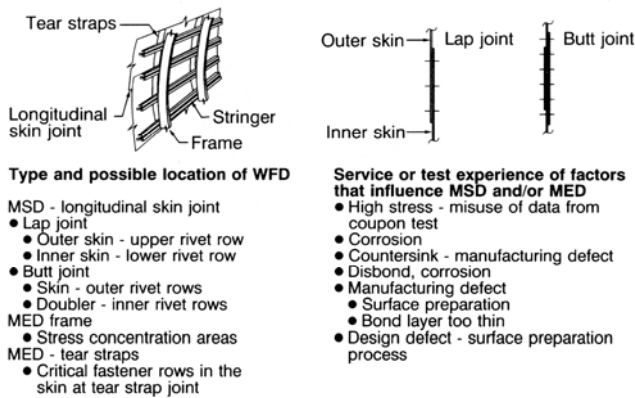
Figure 86. Structures Potentially Susceptible to WFD — Longitudinal Skin Joints, Frames and Tear Straps Examples

Two examples are shown in Figures 86 and 87 summarizing the industry experience regarding longitudinal skin joints including frames and tear straps and aft pressure dome outer ring including dome web splices. Both figures show several

different design configurations with corresponding critical locations.

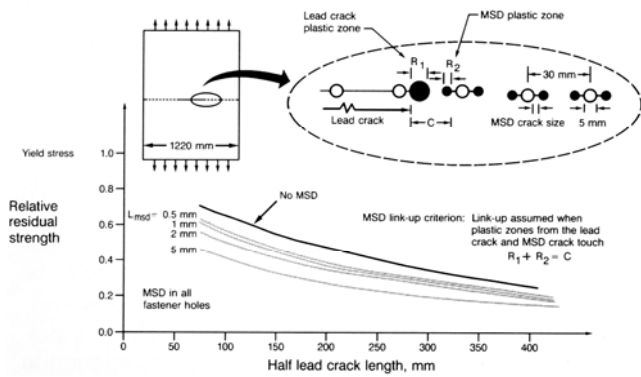
Figure 89. Residual Strength of an Unstiffened Panel Containing Various MSD Sizes

An unstiffened panel with a center crack and equal MSD at each fastener hole is shown in Figure 88. Assumed MSD ahead of the crack will cause interaction and increased crack tip stress intensities for the main crack and the adjacent MSD cracks. A net section stress criteria between the crack tips is used to predict crack extensions. The resulting residual strength line is shown in Figure 89 for various MSD crack sizes. It is important to recognize that the influence of widespread fatigue damage cracking in built-up structures with associated load redistributions may be significantly different from unstiffened panel behavior discussed above. The fact remains that the residual strength of the lead crack is not very sensitive to the MSD crack size. Panel test data shows a similar trend supported by net section failure criteria discussed above, Figure 90.

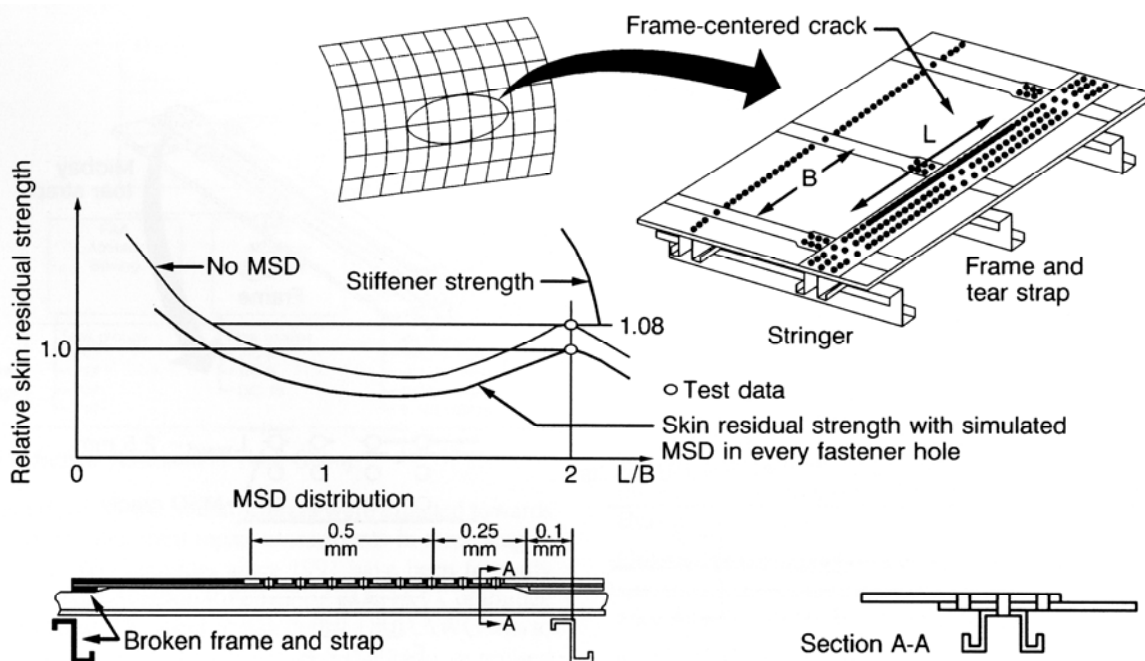
Figure 91. Residual Strength of a Stiffened Panel Containing a Frame Center Crack Along the Lap Joint With Varying MSD Distributions

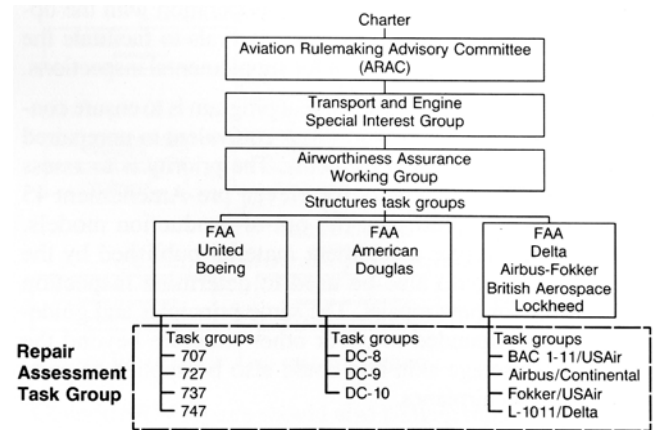
Figure 95. Repair Assessment Task Group

The initial efforts by the manufacturers were directed towards development of consistent repair assessments in three stages. The AATF/AAWG activities since 1991 have been formally incorporated in the Aviation Rulemaking Advisory Committee (ARAC) structure. The specific task defined by AAWG was to develop recommendations concerning whether new or revised requirements and compliance methods for structural repair assessments of existing repairs should be initiated and made mandatory for eleven aging fleet models. Specific tasks and timelines for the Repair Assessment Task Group (RATG) have also been identified including:

- Develop procedures and criteria to assess existing repairs for long term continued operation of eleven pre-Amendment 45 airplanes.
- Evaluate and determine if any rulemaking is recommended for assessments of existing repairs.
- Provide recommendations to the AAWG Steering Committee. Support the development of recommendations to the Transport Airplane and Engine Issues Group (TAES) of ARAC by mid 1993.

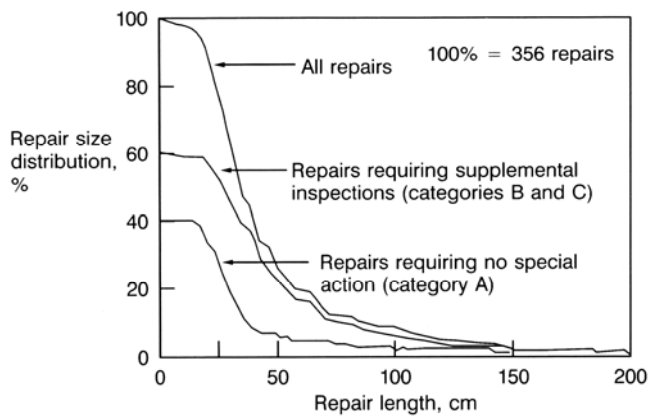
Figure 96. Fuselage Repair Size Distributions Based on Fleet Surveys

These fuselage repair surveys did not indicate an immediate concern for continued structural airworthiness. The size distribution of repairs, Figure 96, indicated a need for assessments to establish inspection requirements for larger repair and/or smaller repairs in close proximity. Operators need updated SRMs and model-specific guidance documents to accomplish their repair assessments.

A total of 356 repairs were evaluated on 30 airplanes over a three-day period. Five different teams comprising engineers conducted these surveys which provided firsthand observations of service repairs in terms of type, proximity, condition and number of repairs relative to standardized common criteria. These surveys demonstrated that some repairs of good quality may inhibit damage detection during normal maintenance activities and therefore may need supplemental inspections due to size, configuration and/or proximity considerations.

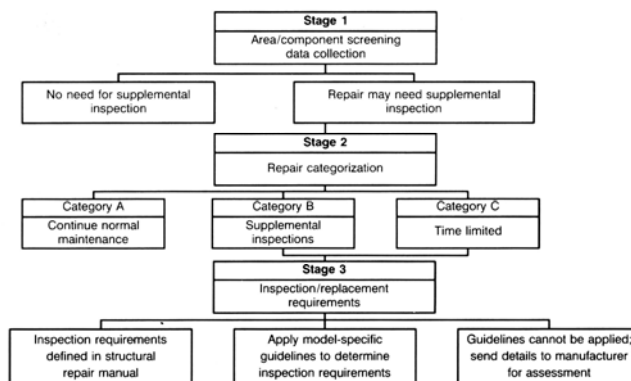
Figure 98. Repair Assessment Stages

The general section of each SRM will contain brief descriptions of damage tolerance considerations, categories of repairs, description of assumed baseline inspections, and repair assessment stages, Figure 98. Data for pressurized fuselage skin will be provided initially to identify repair categories and related information.

The process involves the following three stages, Figure 98:

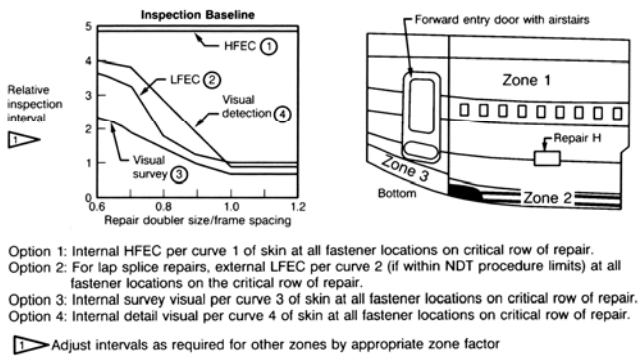
Figure 100. Inspection Options for Fuselage Skin Repairs Requiring Supplemental Inspections

The inspection intervals are based on residual strength, crack growth and inspectability evaluations. The inspection methods and intervals should be compatible with typical operator maintenance practice. Internal inspections are acceptable at D-check intervals while simpler external inspections can be accommodated at multiple C-check intervals.

Guidance material documents for each model will provide a list of structure for which repair assessments are required. Some manufacturers have reduced this list by determining the inspection requirements for critical details. If the requirements are equal to normal maintenance checks, those details were excluded from this list. Figure 100 shows one example of a model-specific repair assessment guidelines for inspection interval selections.
